# Kaikōura Earthquake-Induced Landscape Dynamics Research

## Theme 6 – Assessment Report

Report No: GER 2023/14  
Date: 13 June 2023  
Reference: 5-C3418.00  
Status: Rev A

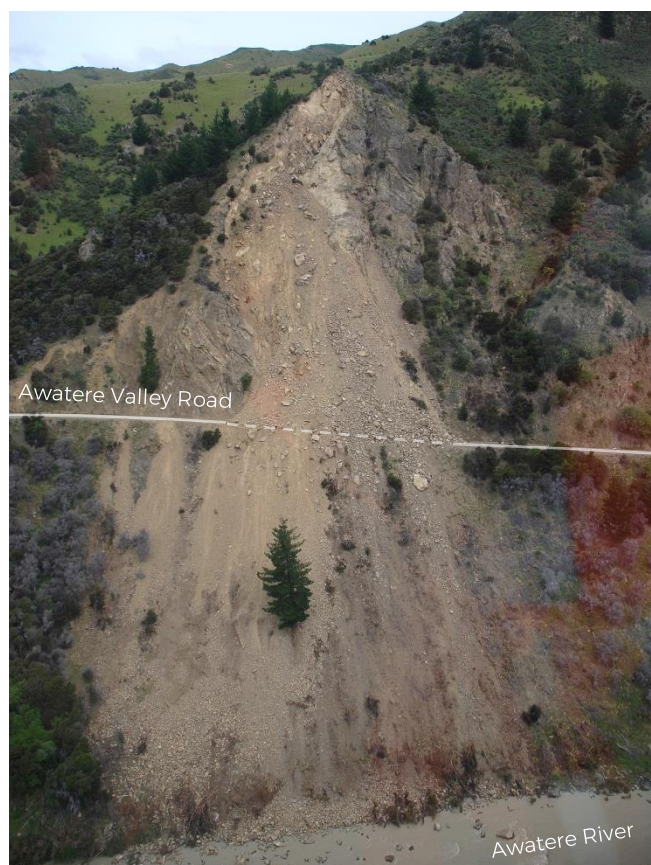
Figure 5: Awatere Gorge landslide, Awatere Valley.

The damage caused by the landslide was blockage of the road by debris. The volume of debris was  $14,000 \text{ m}^3 \pm 5,000 \text{ m}^3$ , based on differencing of pre- and post-earthquake digital surface models. The response and recovery work at the site and the duration of the outage are summarised in Table 5 and described in detail below.

After further reconnaissance and planning, a team of abseilers and helicopters was mobilised to remove the safety hazards posed by the loose debris in the upper slope by scaling, blasting and sluicing. This commenced approximately 2 weeks after the earthquake, with some limited earthmoving at road level during the scaling operation. The main period of earthmoving to clear the road bench began 4 weeks after the earthquake and was carried out using a remote-controlled excavator in conjunction with sluicing of the upper slope by helicopter and sluicing of the lower slope by high pressure hose.

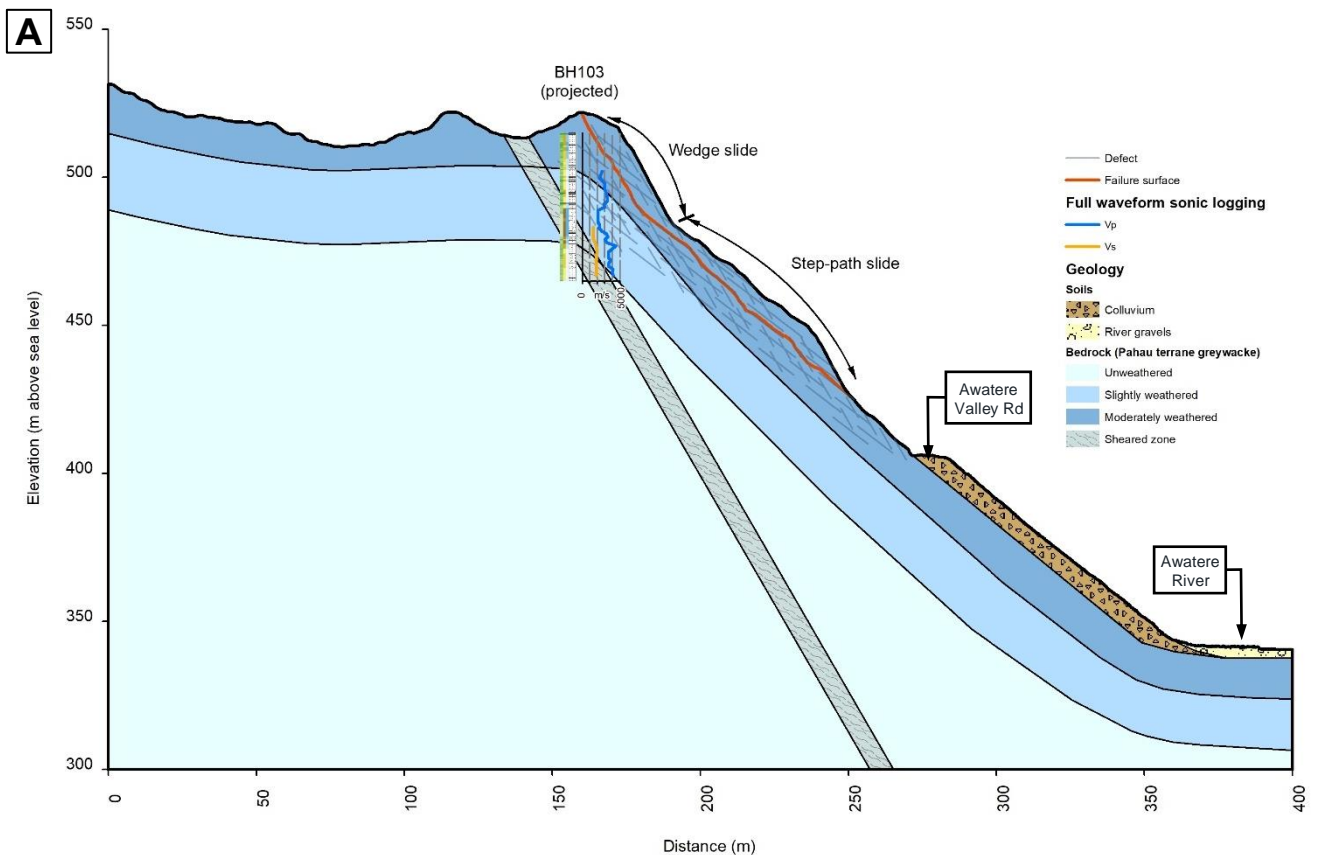
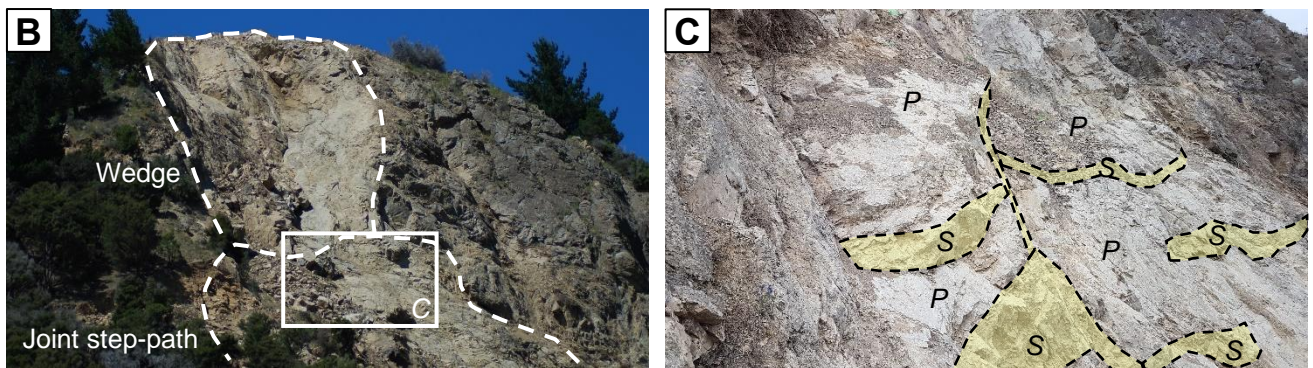
The rock slope failure at the Awatere Gorge site consisted of a combination of wedge sliding in the topmost part of the slope, with joint step-path sliding immediately below the wedge slide (Figure 9). The joint step-path failure is inferred to have propagated along persistent joint surfaces dipping out of the slope at 37° to 54° (JS1), stepping down along short persistence joints (JS2) that dip steeply out of the slope at oblique angles to the more persistent joints (Figure 9C). The wedge

failure occurred along two persistent joint sets dipping  $59^\circ/029$  (JS4) and  $62^\circ/309$  (JS5), with a line of intersection plunging  $50^\circ/352$ . The average orientation of this part of the hillslope before the earthquake was  $63^\circ/008$ .

Figure 9: Ground model of the Awatere Gorge landslide (A) Cross section through the landslide. (B) Wedge sliding failure occurred in the upper part of the slope, with joint step-path sliding in the less-steep part of the slope below. (C) Enlargement of the key joints forming the slide surface, showing outward-dipping slide planes (P) separated by short persistence, steeply dipping steps (S).

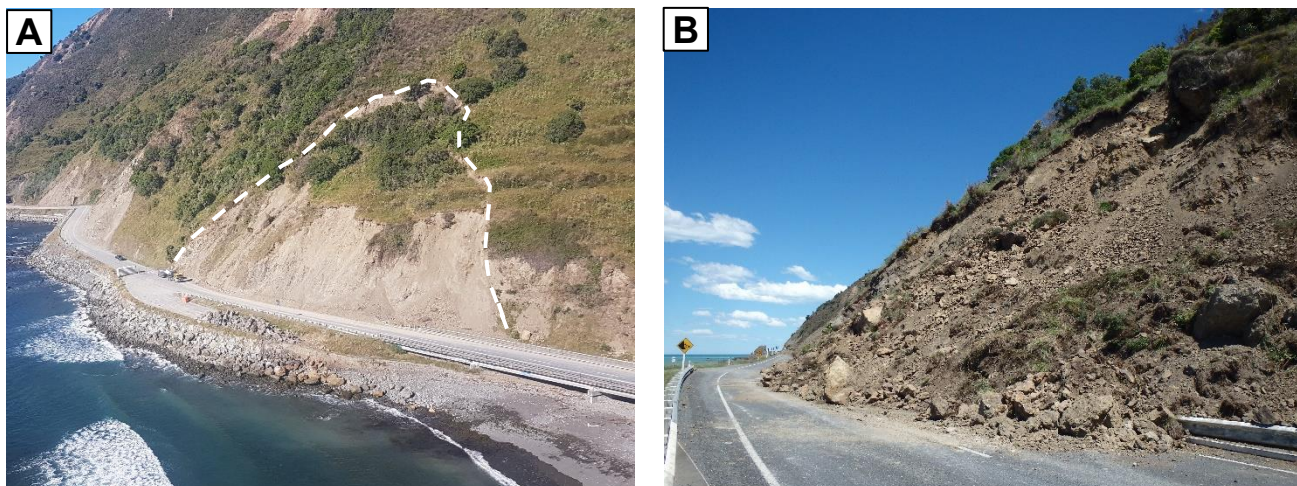
The site is located on SH1 on the south side of the Kahutara Bridge, 8 km southwest of Kaikōura. The Kaikōura earthquake triggered a translational landslide on the hillslope above the road (Figure 10A) as well as wedge and avalanche failures of bedrock on a cut slope above SH1 (Figure 10B).

Figure 10: Kahutara Bridge Site landslide  
(A) Incipient planar slide (dashed line) extending 55 m above road level (photo credit: J. Claridge);  
(B) Rock slides and avalanche from the cutting above SH1 (photo credit: J. Grindley).

The principal damage to the road infrastructure from the Kahutara Bridge site landslide was blockage of the road by debris from the shallow seated failures of the cut slope (Figure 10B). This debris lobe inundated both lanes of the state highway, blocking access along the corridor. The deep-seated landslide did not cause direct damage to the road in the earthquake or in the short-term recovery period. The recovery works and duration of the outage are described below and summarised in Table 7.

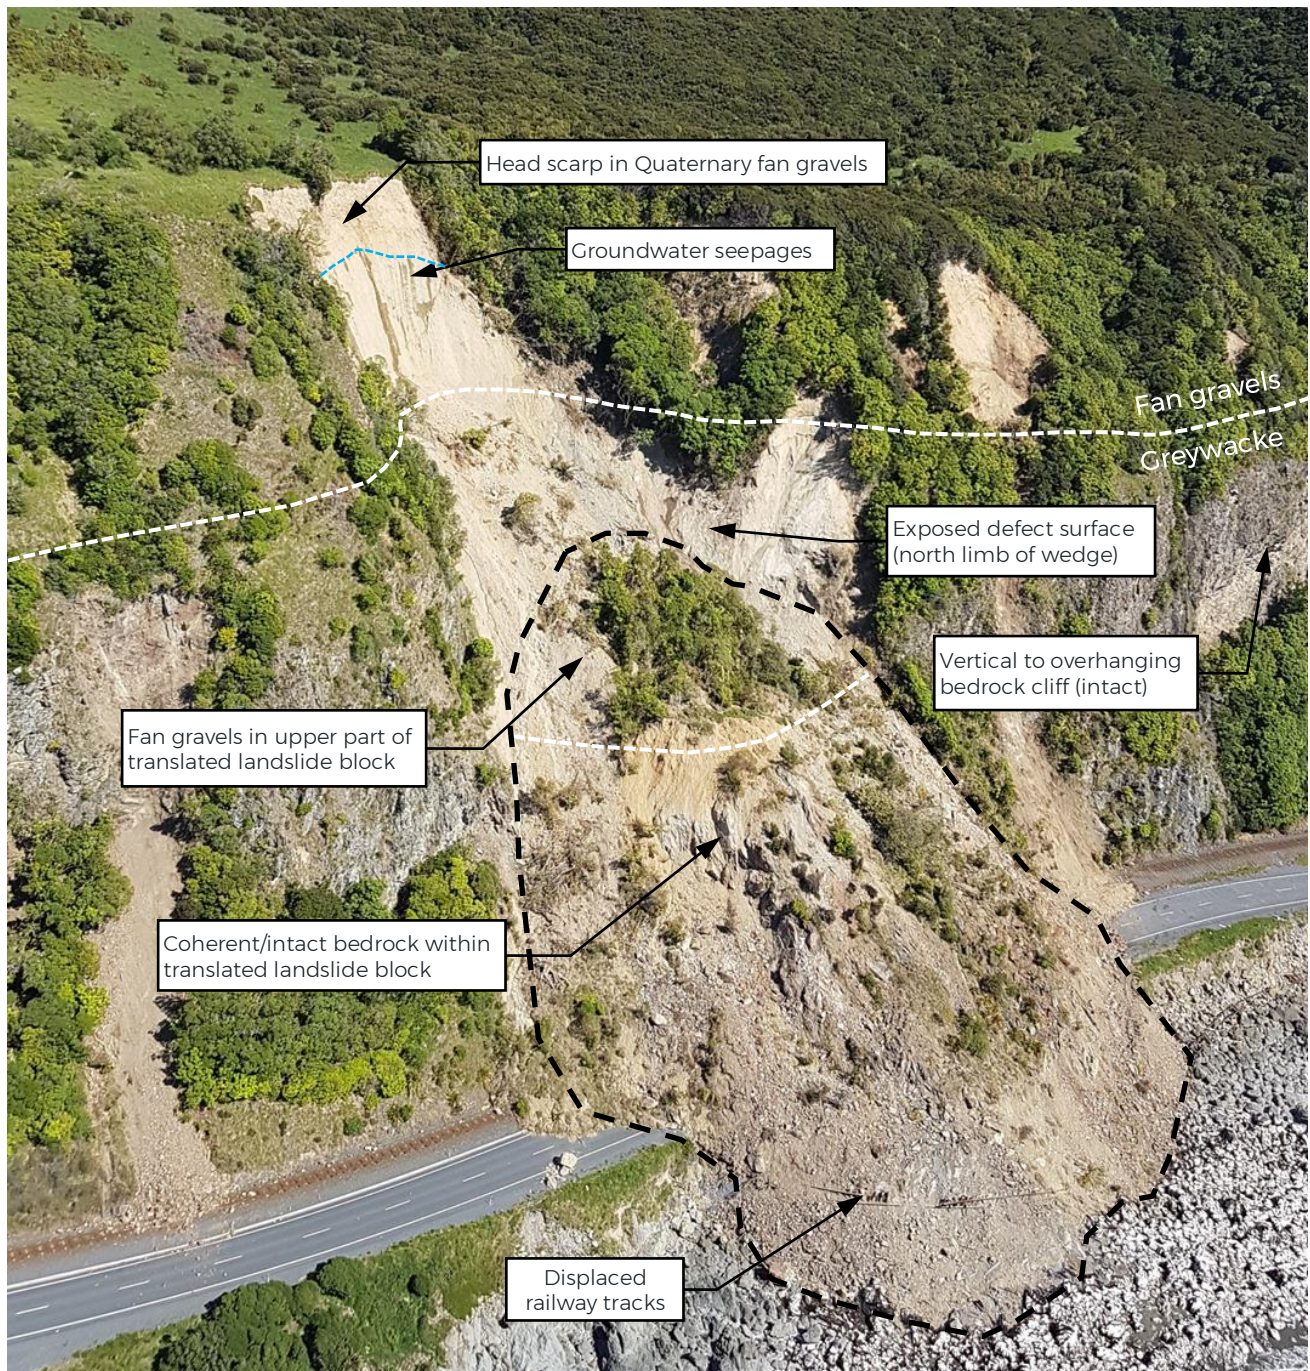
The total volume of the landslide was approximately 100,000 m<sup>3</sup>, with 50,000 m<sup>3</sup> of that volume lodged within the transport corridor, based on differencing of pre- and post-earthquake LiDAR DEMs. These estimates are *in situ* solid volumes, as minimal bulking of the landslide mass occurred as it displaced downslope. Earthworks volumes recorded by NCTIR show 130,000 m<sup>3</sup> of debris was removed (Figure 20). These volumes represent loose unconsolidated spoil removed by dump trucks, and also include additional material cut from the head scarp area (discussed below). In addition to the accumulation of debris, the impact of the sliding landslide mass caused extensive damage to the road pavement and rail structures, displacing the railway tracks by 40 m towards the sea (Figure 19) and causing severe distortion of the tracks to the north and south of the landslide.

Figure 19: Okiwi Bay landslide

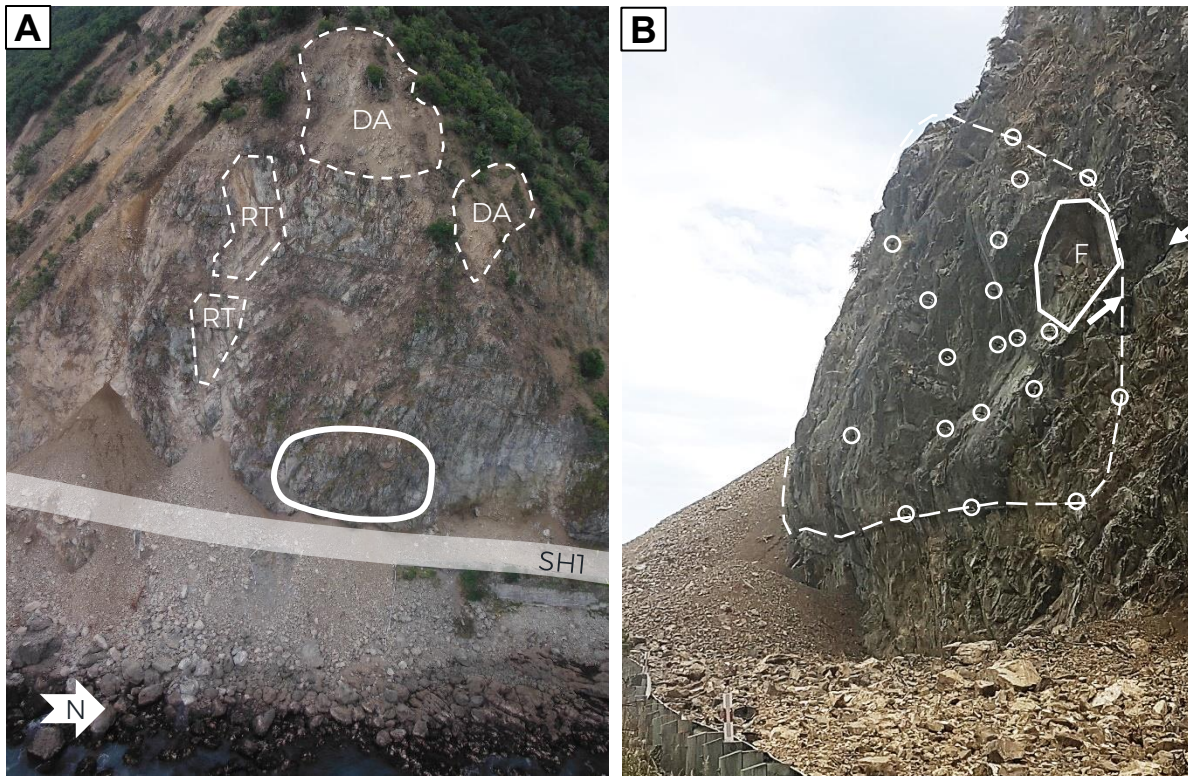
An area of rock bolting and mesh was installed on the slope in 2007, covering  $750 \text{ m}^2$  of the lower part of the cliff. The rock bolts consisted of 3 m long, 32 mm diameter 500 MPa bars grouted into 55 mm diameter drillholes. The rock bolts were positioned in a grid pattern with 3 m to 4 m spacing. The mesh consisted of Tecco rock fall mesh constructed by Geobrugg (C. Parkes, pers. comm., 2022). The area of rock bolting on the north face of the cliff is shown in Figure 21. The rock bolts did not fail in the earthquake, however limited failures occurred between the bolts, either as disaggregated failure of loose rock on the slope surface, or combined toppling and sliding along a stepped-planar failure surface of outward-dipping joints. The disaggregated failures were of sufficiently small volume that they were readily contained by the mesh facing; the deeper joint-controlled failure of blocks of rock between the bolts ruptured the mesh at the northern end of the stabilised section of slope (Figure 21). Dilation of outward-dipping defects and minor displacement of the rock block occurred in the area adjacent to this failure.

Figure 21: Slope failures on the northeastern cliff face above SH1 at Ohau Point. (A) Debris avalanches (DA) and rock topples (RT) were triggered in the middle and upper parts of the slope, inundating the road bench with debris. The area circled in the lower slope is the approximate area of slope stabilisation. (B) The northern end of the area of rock bolts (circled) and mesh in the lower part of the slope. Failure (F) of a small section of the rock face occurred by combined toppling and sliding on a stepped-planar failure surface of outward-dipping joints at the lateral margin of the meshed area. In the adjacent part of the slope (between the arrows), dilation of joints and displacement of the joint-bounded block occurred but did not transition to failure (photo credit: J. Grindley).

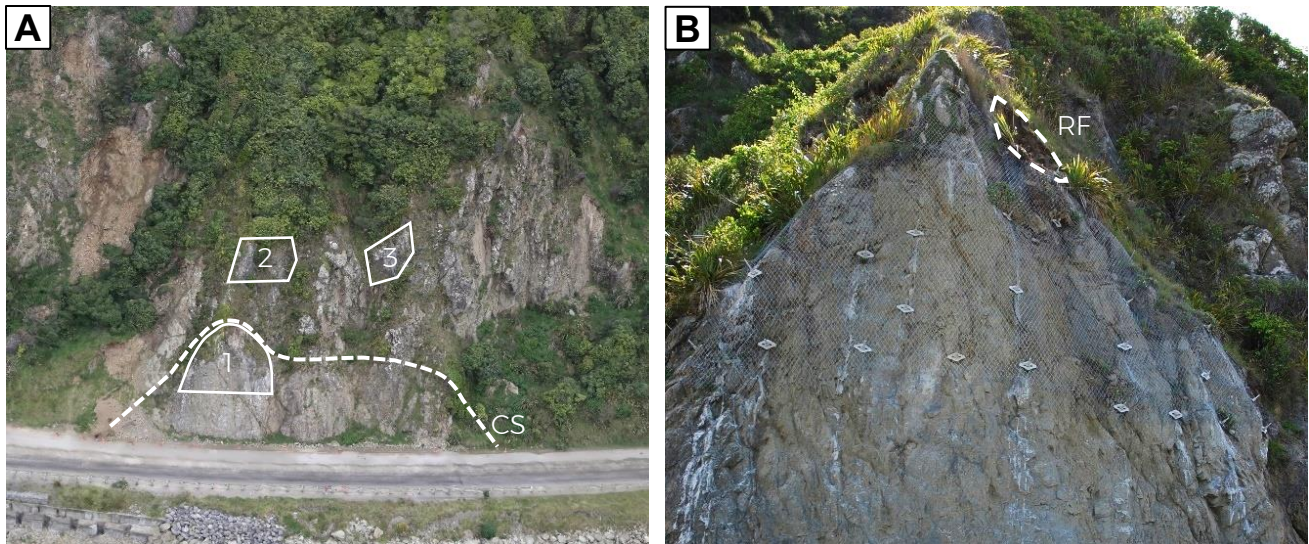
Failure of the unsupported parts of that slope consisted of wedge failures along intersecting joints at the top of the cut slope. Within the areas of mesh and rock bolts, deformation of the rock slope consisted of incipient displacement of rock wedges between the bolts, failure of small wedges of rock and minor spalling of loose debris from the face. Where this occurred, the mesh retained the failed rock, with only fine gravel-sized debris passing through or beneath the mesh. The unmeshed parts of the slope generated larger volumes of debris from wedge failures, with the resulting rock fall inundating both lanes of the state highway.

Figure 22: Cut slope and rock bolting areas north of the Okiwi Bay landslide. (A) Areas of rock bolts and mesh (numbered 1-3) on the bluff above SH1 on the western side of Okiwi Bay. The extent of the cut slope (CS) is shown by the dashed line. (B) Rock bolts and mesh in area 1 on the cut slope with no observed deformation at the surface following the 2016 earthquake. A minor rock fall (RF) occurred from the slope above the top of the mesh.

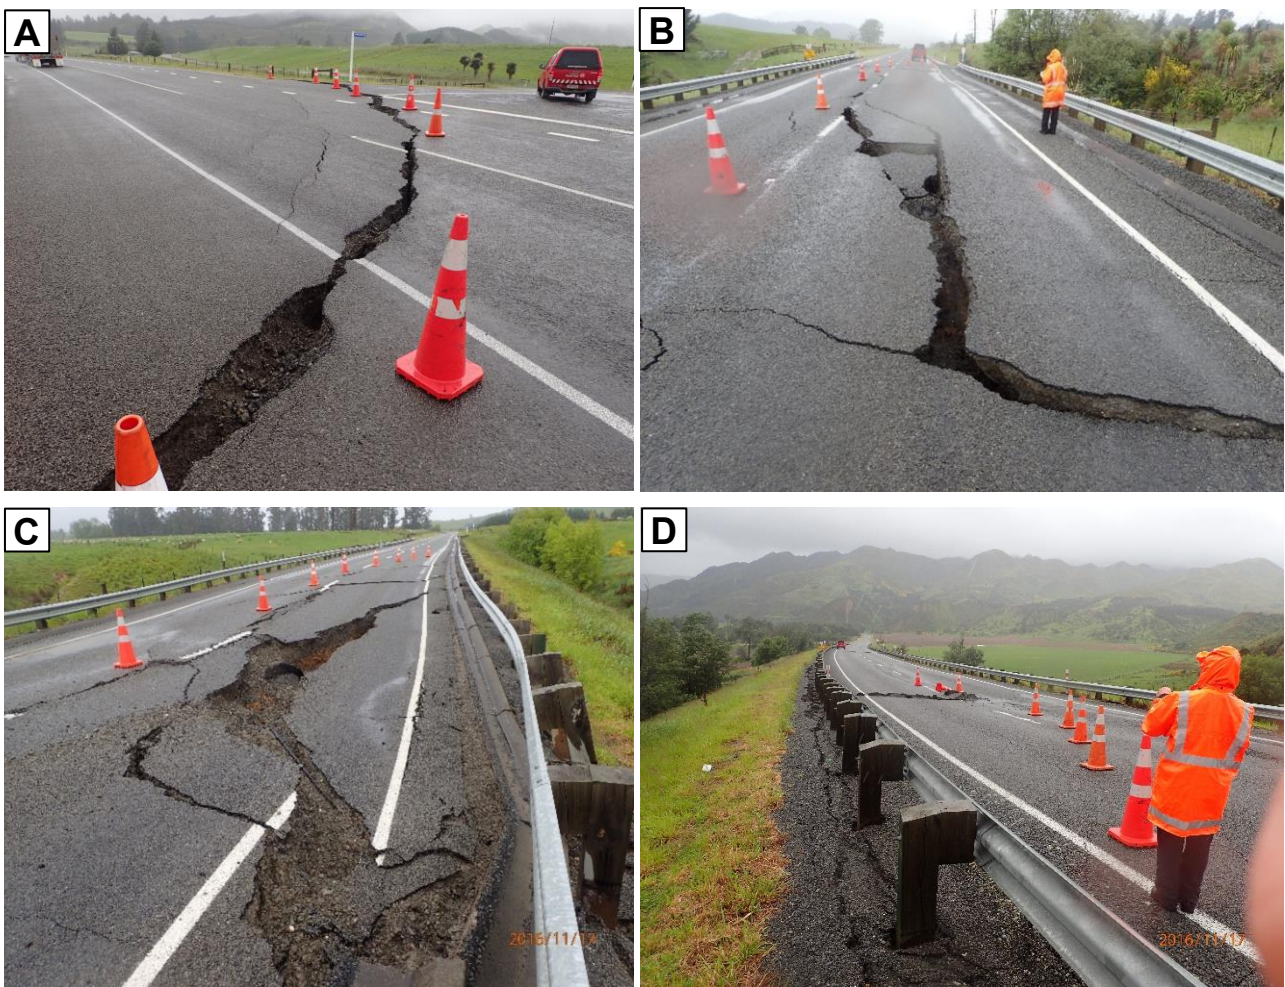
Nearly all of the fill embankments experienced some form of damage in the earthquake, while none of the cut slopes were affected. Damage of the fills ranged from localised and minor cracking of the pavement at the margins of the fill bodies to extensive settlement and slumping. Frequent but minor cracking of the road surface occurred throughout the site, particularly at the boundaries of the fill bodies (i.e. at the interface between the fill materials and natural soils) and near the crests of the fill slopes. The pavement cracking was also accompanied by settlement of the road surface, which is presumed to be in response to densification of the underlying fill due to ground shaking. Development of wider and deeper tension cracks occurred where the fill bodies were thicker and the batter slopes were steeper. The most severe damage occurred to the fill embankments at Hawkswood Stream, Homestead Creek, Culvert 55 and Chilly Creek, which are shown in Figure 24 and described below.

Figure 24: Damage to fill embankments on the Hawkswood to Ferniehurst section of SH1. (A) Hawkswood Stream; (B) Homestead Creek; (C) Culvert 55; (D) Chilly Stream. Photo credits: C. Parkes.

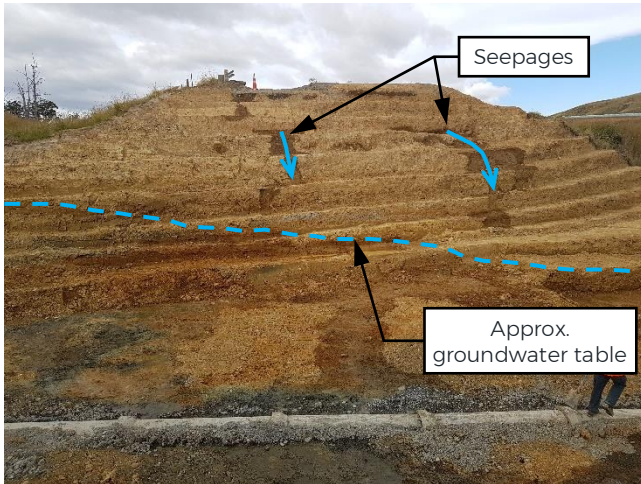
A translational to semi-rotational slump formed on the northwestern side of the fill slope at Culvert 55. The damaged embankment was excavated following the earthquake, and replaced with reinforced fill. During the excavation works, several areas of groundwater seepage at high levels within the fill were observed (Figure 25), and the concrete pipe was found to be completely blocked with silt and debris from the farm pond above, resulting in the groundwater table sitting several metres above the level of the culvert.

Figure 25: Post-earthquake excavation of the embankment at Culvert 55

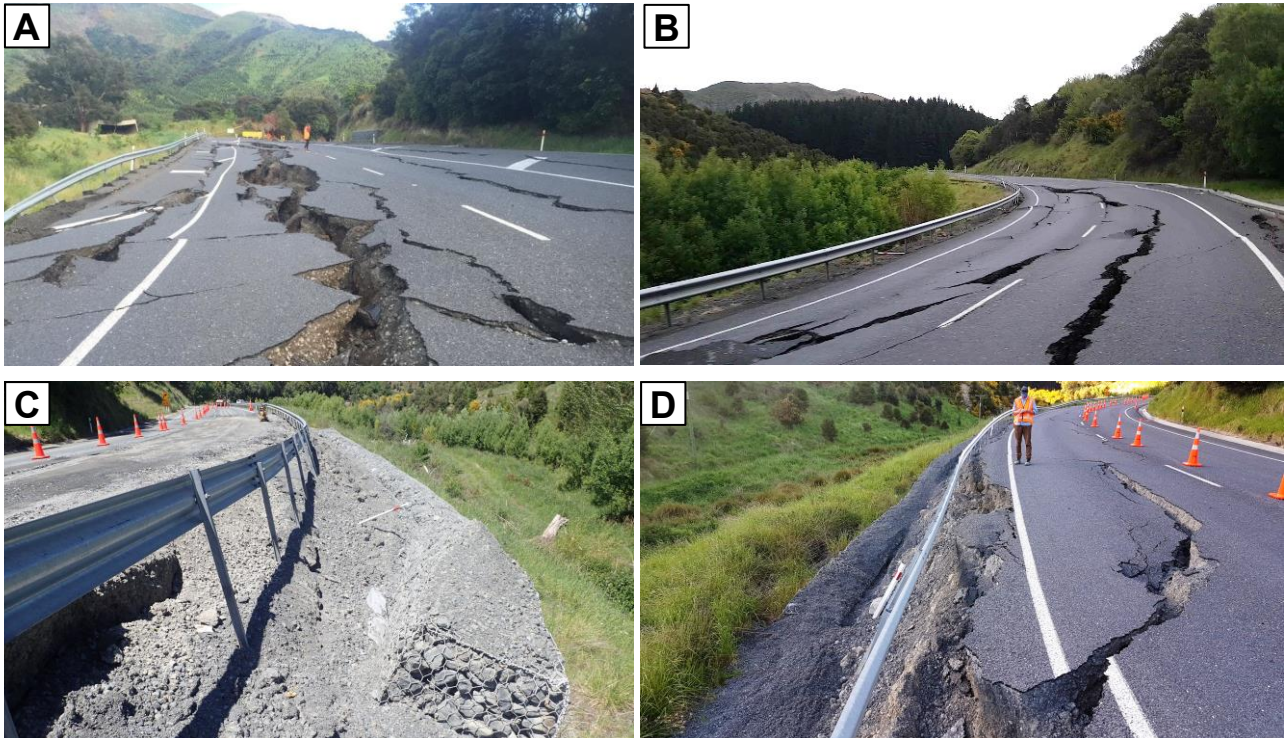
Figure 28: Major damage to slope assets along the Hundalee Forest section of SH1. (A) Translational failure of a gabion wall and spreading of the road embankment at RP 185/2.65 (photo credit: stuff.co.nz). (B) Displacement of a gabion wall and the road embankment at RP 185/3.05 (photo credit: D. Coll). (C) Overturning failure of an unreinforced gabion wall (photo credit: M. Broughton). (D) Translational failure of a gabion wall and slumping of the road embankment (photo credit: K. Jadrnicek).

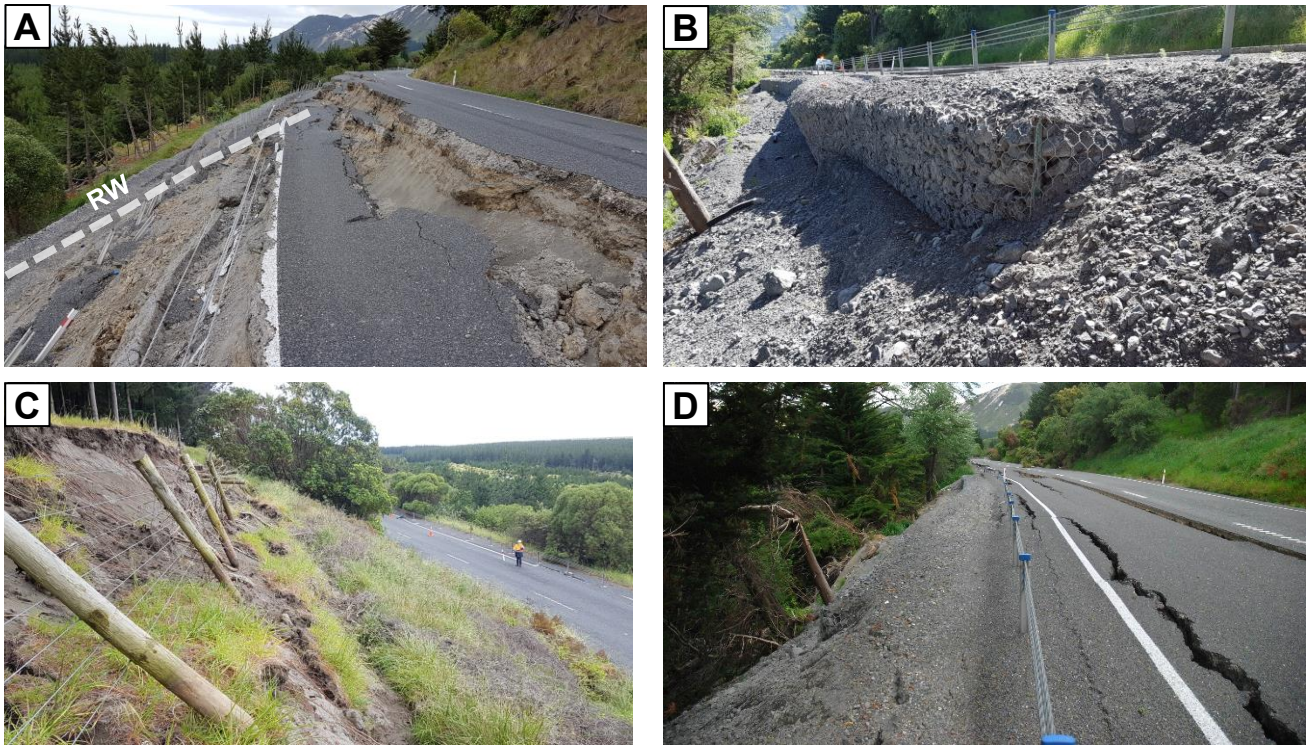
*Figure 33: Damage to geotechnical slope assets at the Sandpit  
(A) Translational failure of the road embankment and unreinforced gabion retaining wall (RW).  
(B) Damage to the gabion wall (photo credit: E. Boam).  
(C) Slumping of the cut slope above the road (photo credit: E. Boam).  
(D) Displacement of gabion wall causing settlement and cracking to the middle of the road.*

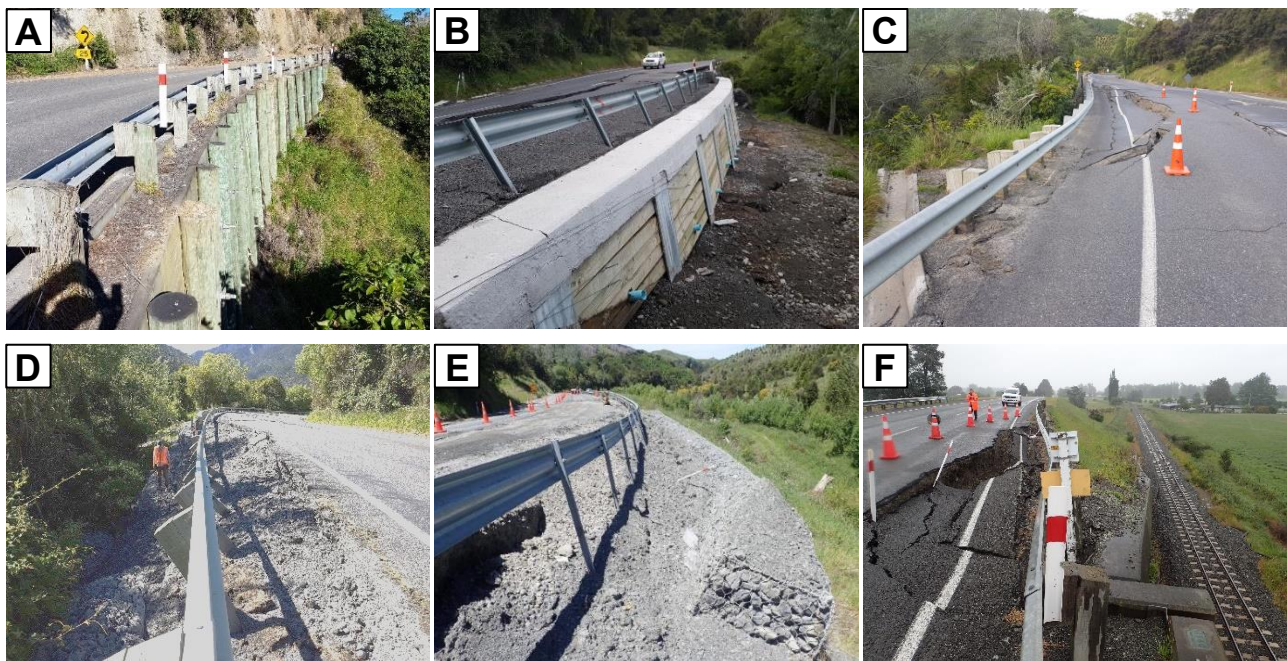
Figure 34: Examples of damage to retaining walls.
