Kaikōura Earthquake-Induced Landscape Dynamics Research

Theme 6 – Recommendations for earthquake resilient design of earthworks

Date: June 2023
Project no: 5-C3418.00
Report No: GER2023-15
Status: Final

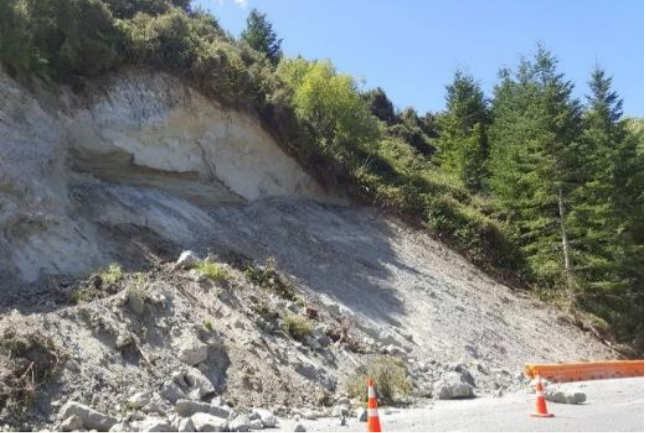
Failure mechanism	Description	Contributing factors	Significance	Example
Combined defect-rock mass	<p>Kinematic release on persistent planar defects and shear failure through the rock mass along the base by a secondary mechanism, e.g. shear failure through weak rock mass or sliding along a secondary defect.</p> <p>Generally coherent slide blocks, with some internal deformation.</p>	<p>Unfavourable persistent defects.</p> <p>Low rock mass strength.</p> <p>Over-steepened toe of slope.</p>	<p>Deep-seated failures, often extended over the full height of the slope.</p> <p>Mechanism of some of the largest failures along the transport corridor.</p>

<p>Mason River, Inland Road (photo credit R. Ridl)</p>
Disaggregated rock mass failure	<p>Sliding and tensile release along a rough, irregular path of short-persistence, interconnecting, non-systematically oriented defects.</p> <p>Disaggregation of the landslide mass due to closely spaced fractures and lack of confining pressure at shallow depths within the slope, leading to complete strength loss and runout as a rock avalanche.</p>	<p>Jointed/dilated and low strength rock mass.</p> <p>Upper parts of steep slopes most susceptible.</p>	<p>Common failure type.</p> <p>Although generally shallow-seated these generated significant volumes of debris and caused the most damage and disruption to the transport corridor (e.g. Ohau Point).</p>

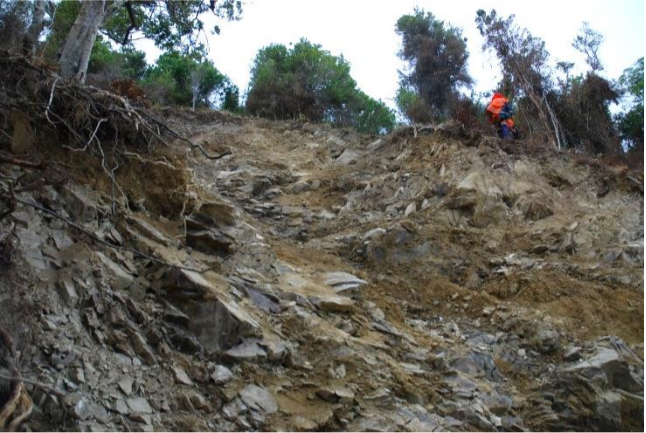
<p>Iron Gate (NCTIR slip no. NRP2), SH1</p>

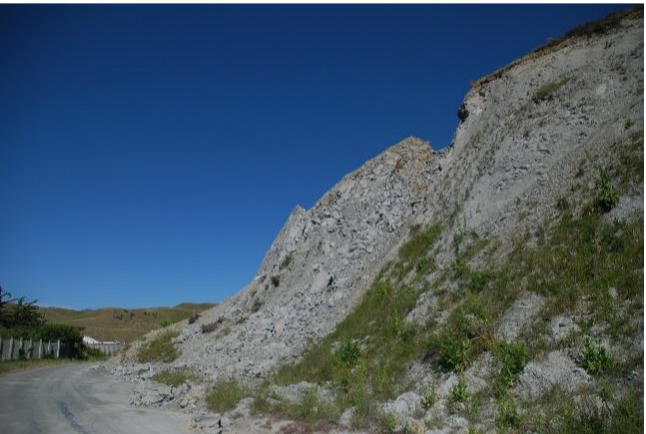
Rotational/coherent slides	<p>Deep-seated rotational slumps in massive, weak rock.</p> <p>Sliding mass generally remains coherent with little internal distortion due to limited displacement of the landslide.</p>	<p>Low strength, homogeneous rock mass.</p> <p>Oversteepened slopes e.g. coastal cliffs, river banks and road cuts.</p>	<p>Deep-seated failures, often extended over the full height of the slope.</p>

<p>Lake Grassmere, Kaparu Road</p>

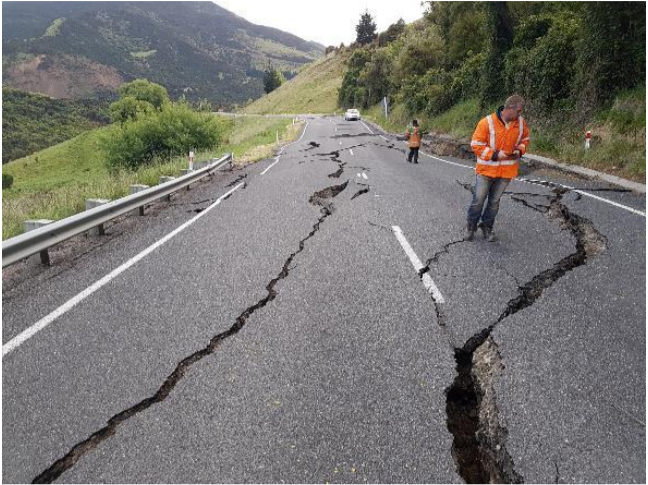
Failure mechanism	Contributing factors	Form of damage	Significance/transport impacts	Example
Subsidence	Loose fill density	Settlement, vertical displacement, cracking.	Cracking of road surface, difficulty in driving across.

Hundalee Hills, SH1 (photo credit D. Coll)
Translational	Steep fill slope	Cracking, vertical and lateral displacement. Disaggregated runout.	Wide cracking of road surface, vertical steps, slumping and loss of (part or full) carriageways, loss of lane(s).

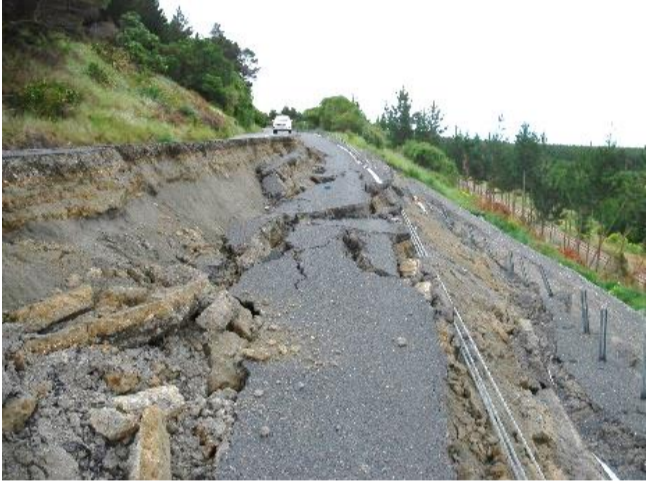
The Sandpit, SH1
Rotational (or semi-rotational)	Weak surfaces within fill or foundations, relic surfaces. Perched or high groundwater.	Vertical and lateral displacement. Gross failure, slumping. Debris flow, fluidised flow.	Wide cracking of road surface, vertical steps, slumping. Loss of (part or full) carriageways, impassable. Deformation and displacement of buried structures (culverts, tunnels).

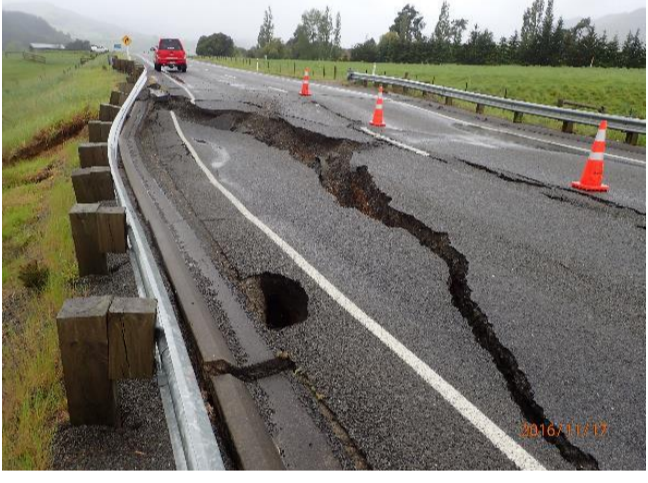
Culvert 55, Hawkwood, SH1 (photo credit C. Parkes)

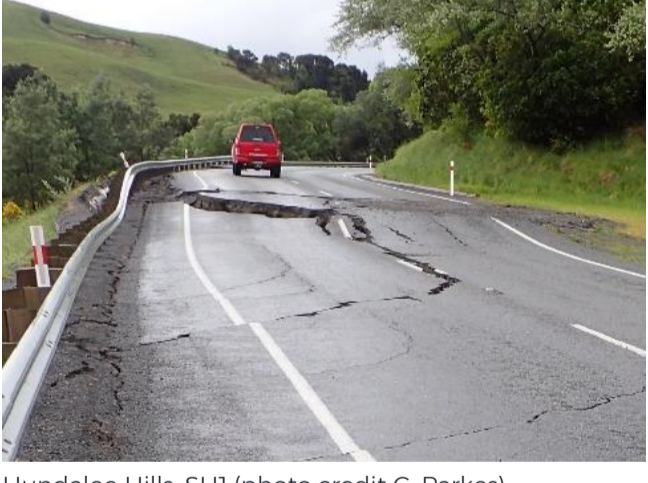
Lateral displacement	Poor foundations. Amplification of shaking.	Cracking, vertical and lateral displacement.	Wide cracking of road surface, vertical steps, impassable.

Hundalee Hills, SH1 (photo credit C. Parkes)
Thrust	Load from structure	Cracking, vertical and lateral displacement.	Wide cracking of road surface, vertical steps, impassable.	
Liquefaction	Loose saturated cohesionless fill / foundation materials.	Subsidence, lateral spreading. Vertical and lateral displacement.	Wide cracking of road surface, vertical steps, impassable.

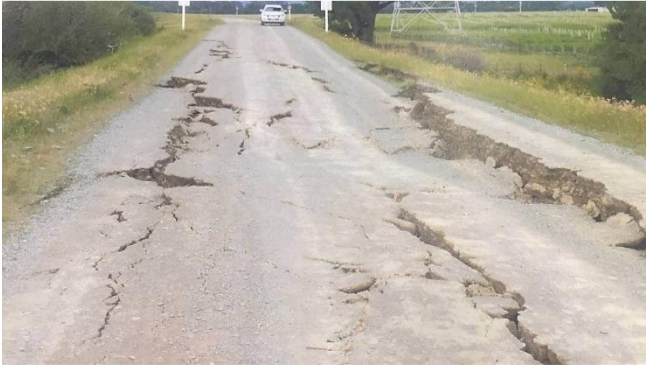
Wairau Diversion stopbank, near Blenheim (photo credit Marlborough District Council)

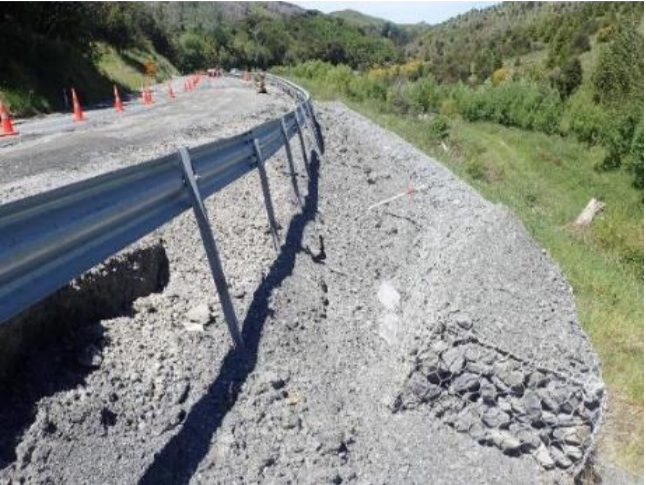
Failure mechanism	Contributing factors	Form of damage	Significance/transport impacts	Example
Overturning	Founded on top of slope, not tied back.	Wall detached and rolls down slope.	Loss of lane(s).

<p>Overturning of unreinforced gabion wall, Hundalee Hills, SH1 (photo credit M. Broughton)</p>
Displacement	High earthquake load or designed for displacement.	Cracking of surface above.	Cracking of road, vertical steps in road pavement.

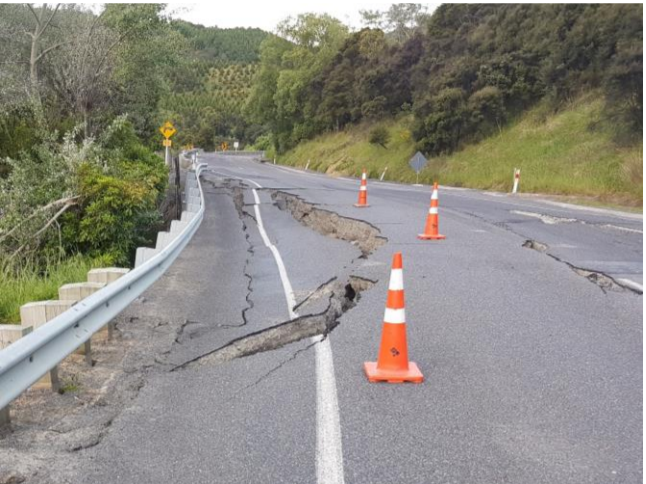
<p>Displacement of unreinforced crib wall within gully, Hundalee Hills, SH1 (photo credit M. Broughton)</p>
Rotational slip with bulging of the wall	Overloaded due to surcharge and earthquake loads.	Damage to wall due to bulging and rotation.	Cracking / slumping of road pavement.

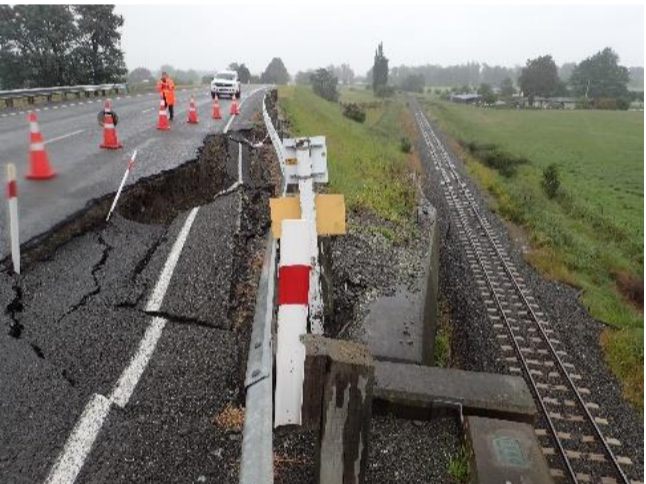
<p>Rotational slump and bulging of crib wall supporting bridge abutment, Parnassus, SH1 (photo credit C. Parkes)</p>
Global rotational failure of wall through foundation	Weak foundation materials.	Complete failure.	Loss of road platform (lanes).

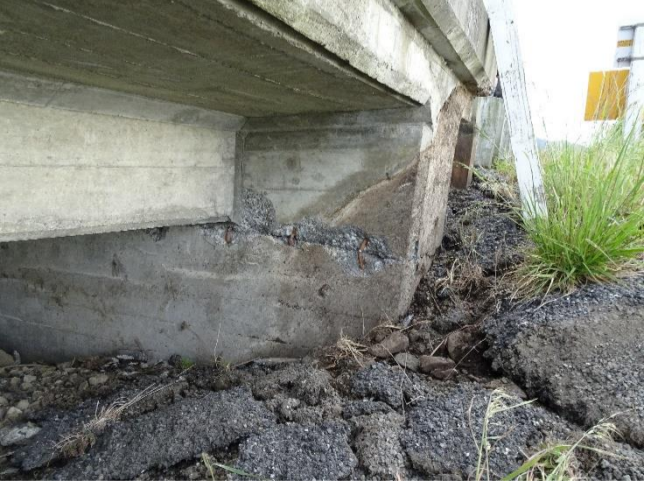
Structural failure of abutment walls	High earthquake loads and structural thrust.	Cracking / displacement of structure.	Cracking, reduced load capacity of bridge/structure.

<p>Cracking of Oaro rail overbridge abutment, SH1 (photo credit G. Saul)</p>

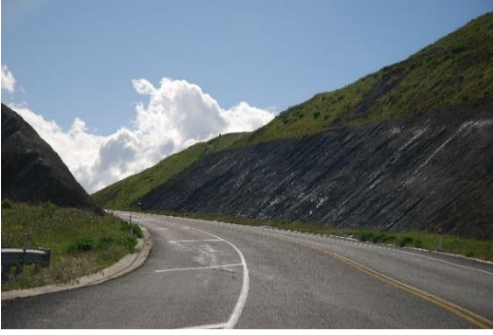
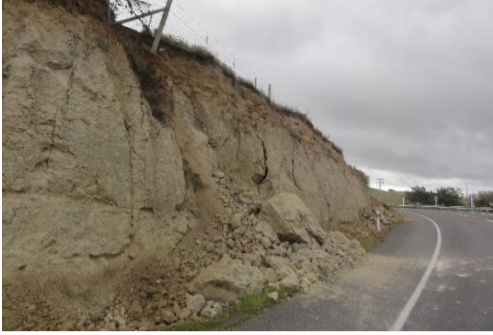
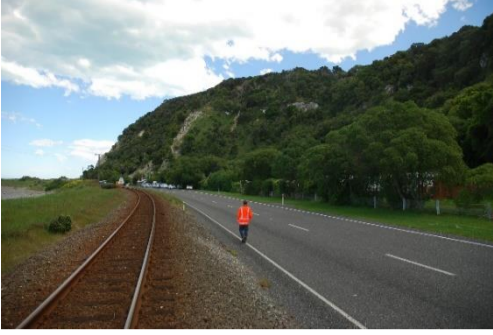
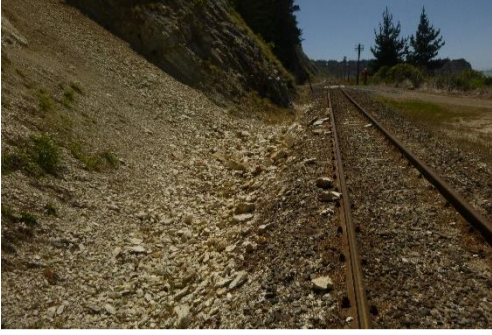
Availability State ¹ and direct damage impacts			
<p>(1) Full access: No damage, or slope failures did not encroach into road/rail corridor sufficiently to affect access</p>

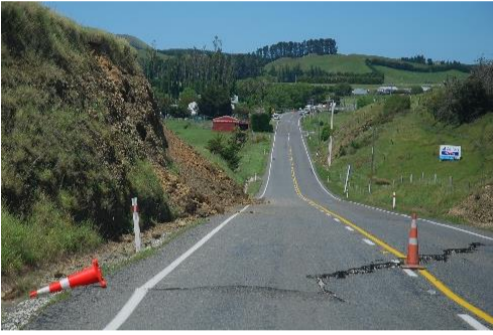
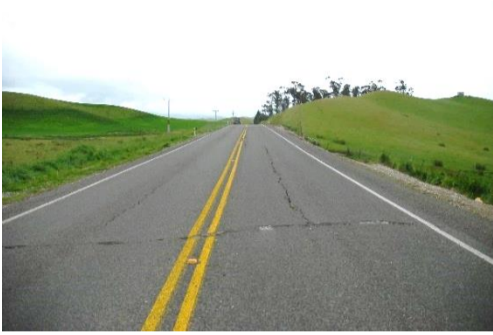
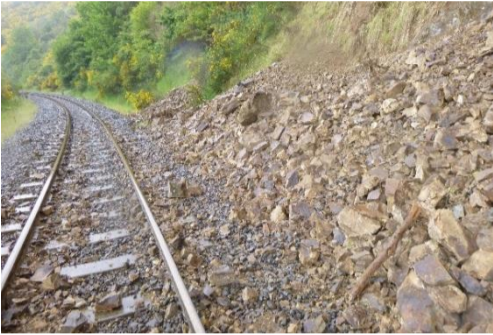
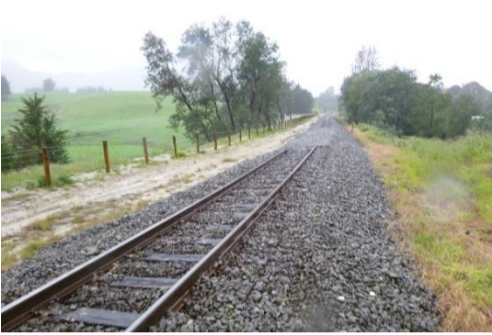
<p>(2) Poor: Slow access. Minor cracking of road pavement (limited or no vertical displacement across the cracks), minor deformation of rail tracks (able to run normal traffic possibly under reduced speed limits), inundation of the live traffic corridor by small volumes of landslide/rock fall debris</p>

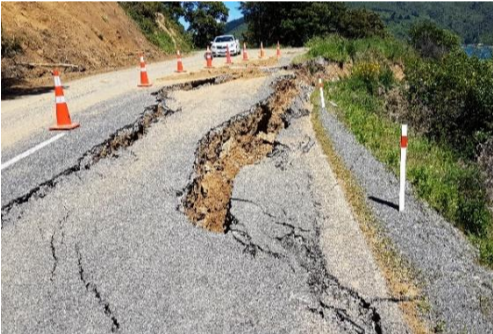
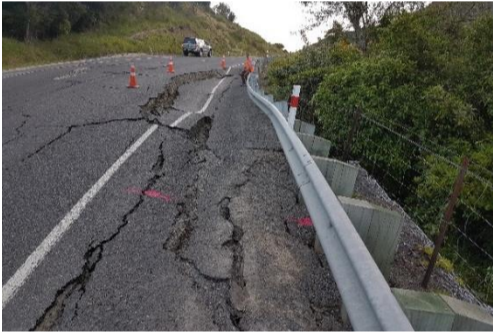
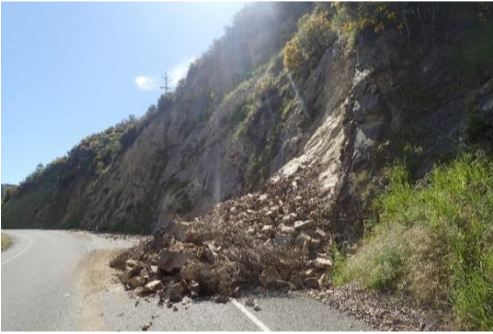
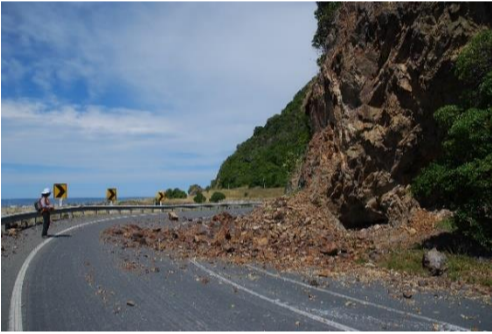
<p>(3) Single lane (road corridor only): Loss of half the road width due to (a) failure of fill embankments or retaining walls on slopes below the road, or (b) blockage of one lane by rock fall or landslide debris from slopes above the road</p>

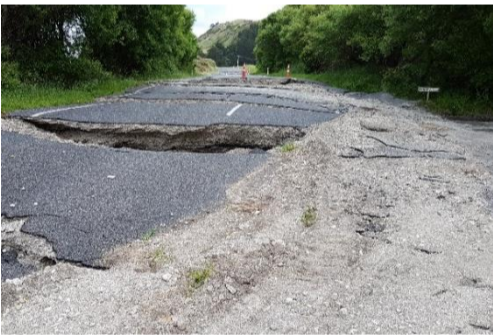
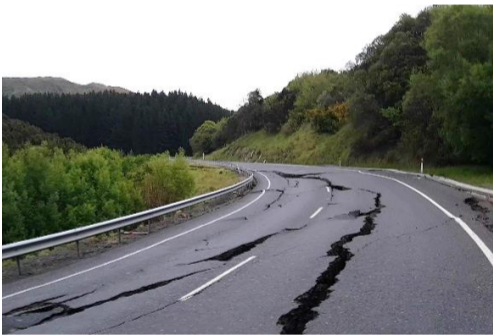
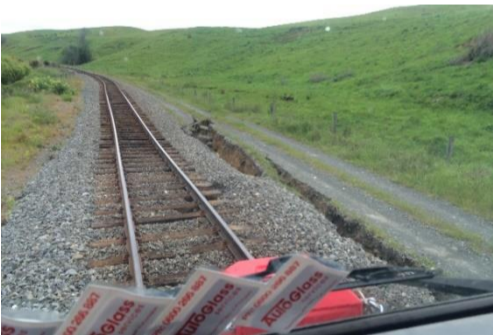
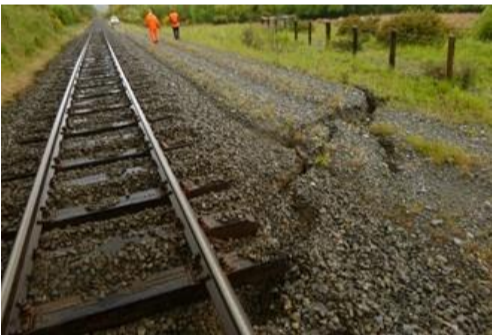
<p>(4) Difficult: Road only accessible in a single lane by 4WD vehicles, rail only accessible with temporary speed/weight restrictions. Damage impacts consist of subsidence and deformation of the road or rail from slope failure extending beneath the whole embankment</p>

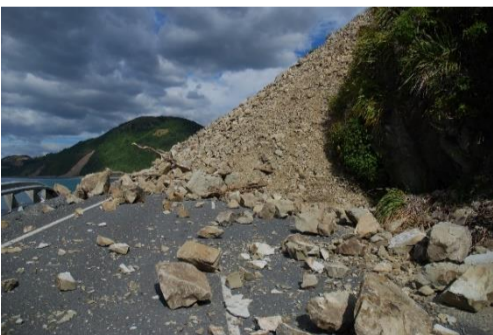
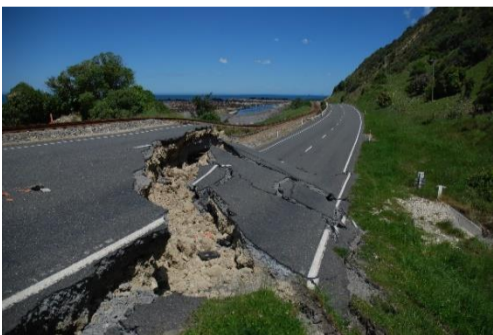
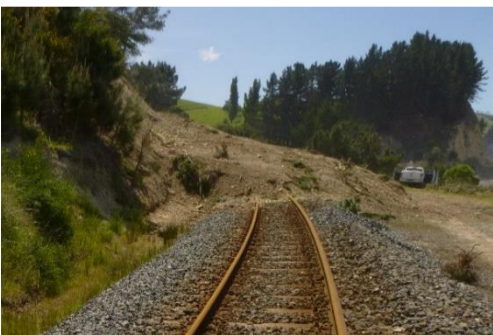
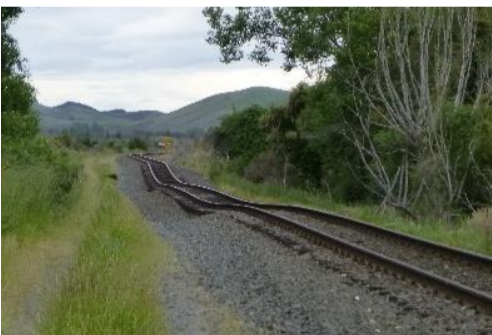
<p>(5) Closed: Corridor unavailable for use. Damage impacts consist of complete blockage by slip debris, or extensive deformation of the road/rail from fault rupture or underslips through the whole embankment</p>

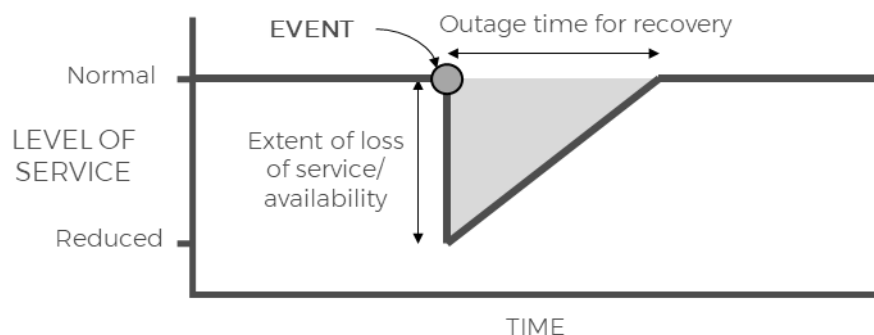
Figure 4: Resilience metrics for transport networks (Brabhaharan et al., 2006)

The resilience of infrastructure such as roads is defined as the ability to recover readily and return to original functionality following an adverse event. Brabhakaran *et al.* (2006) applied this concept to transport networks, using the metrics of 'availability state' to represent the degree of damage or loss of functionality and 'outage state' to represent the time required to restore the pre-event level of service. These are illustrated in Figure 4.

The resilience of infrastructure can be maximised by reducing the shaded triangular area in Figure 4. This can be achieved by developing infrastructure in a way that (a) reduces damage, and the consequent loss or reduction in functionality, and (b) enhances the ability to recover quickly from such a reduction, including strategies for organisations and communities to cope with or contain losses effectively, and emergency response strategies to enable rapid recovery (Bruneau et al., 2003).

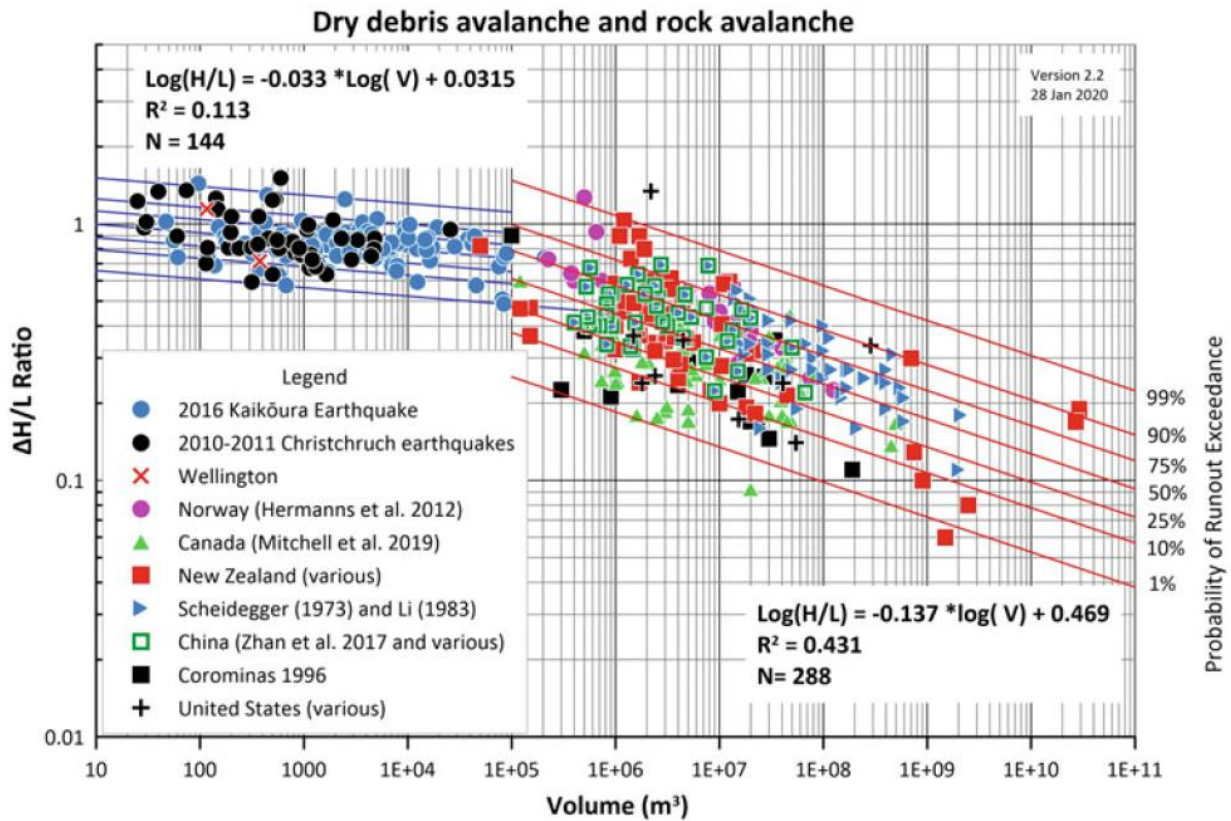
Brideau *et al.* (2021b) collated NZ and international datasets of landslides with recorded volume and runout data, which provide the basis for empirical assessment of landslide runout for given volumes and probabilities of exceedance. The type and volume of the landslide and the characteristics of the slope in the runout path will affect the runout distance. In general, confined landslides (such as debris flows) travel further than landslides on unconfined open slopes, rainfall-triggered landslides with wet/saturated debris have travel further than earthquake-triggered landslides with dry debris of similar volumes, and larger volume landslides travel further than smaller volume landslides of the same type (Brideau *et al.*, 2021a). Figure 6 shows the relationships between runout (expressed as the ratio between the fall height (ΔH) and length (L)) and landslide volume for dry debris/rock avalanches.

Figure 6: Empirical relationships between landslide volume and runout ($\Delta H/L$ ratio) for dry debris avalanches from Brideau et al. (2021b).

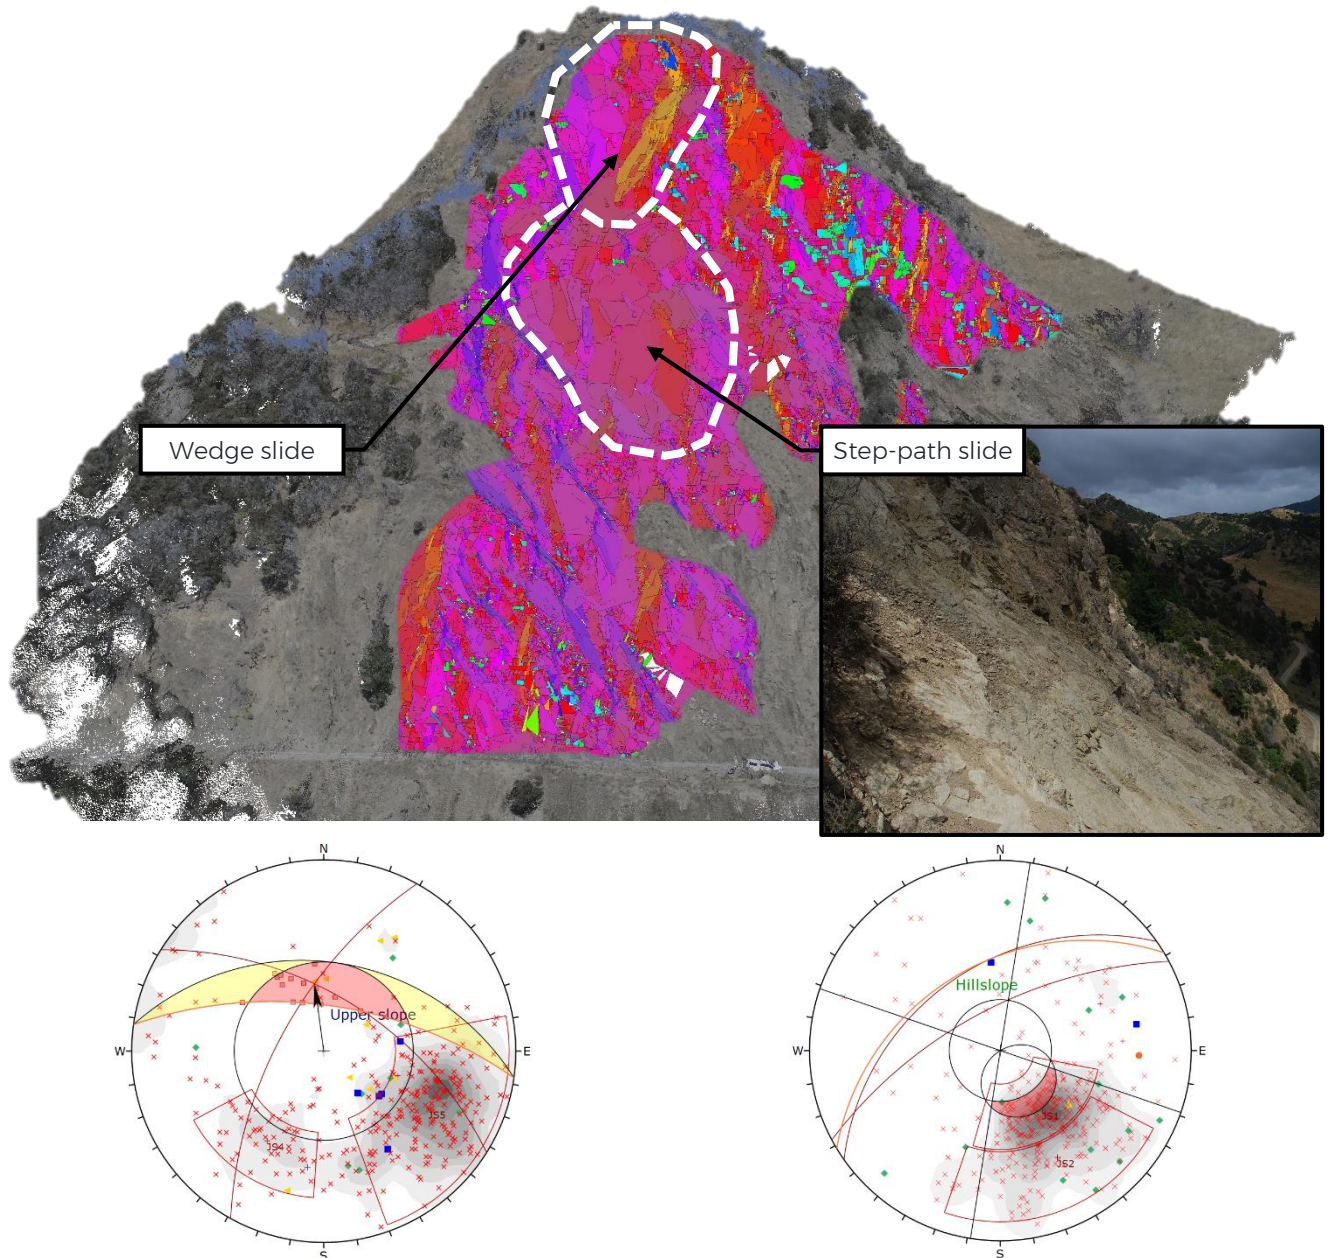
UAV or drone surveys are particularly useful to assess the slope geometry and conditions, as well as assess rock exposures using a 3-dimensional point cloud to identify rock defects that can control failure. An example of the use of such techniques to assess rock defects is illustrated in Figure 7.

Figure 7: Point cloud and interpreted structural defects from UAV survey and stereograph analysis of wedge and step-path slides, Awatere Valley.
