# Kaikōura Earthquake-Induced Landscape Dynamics Research

## Theme 6 – Assessment Report

Report No: GER 2023/14  
Date: 13 June 2023  
Reference: 5-C3418.00  
Status: Rev A

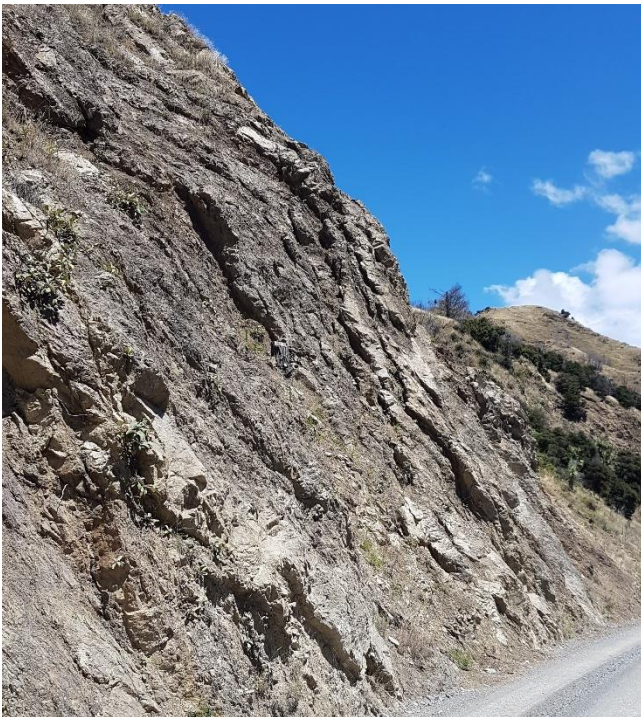
Figure 7: Folded and sheared bedding exposed in the road cuts on Awatere Valley Road.

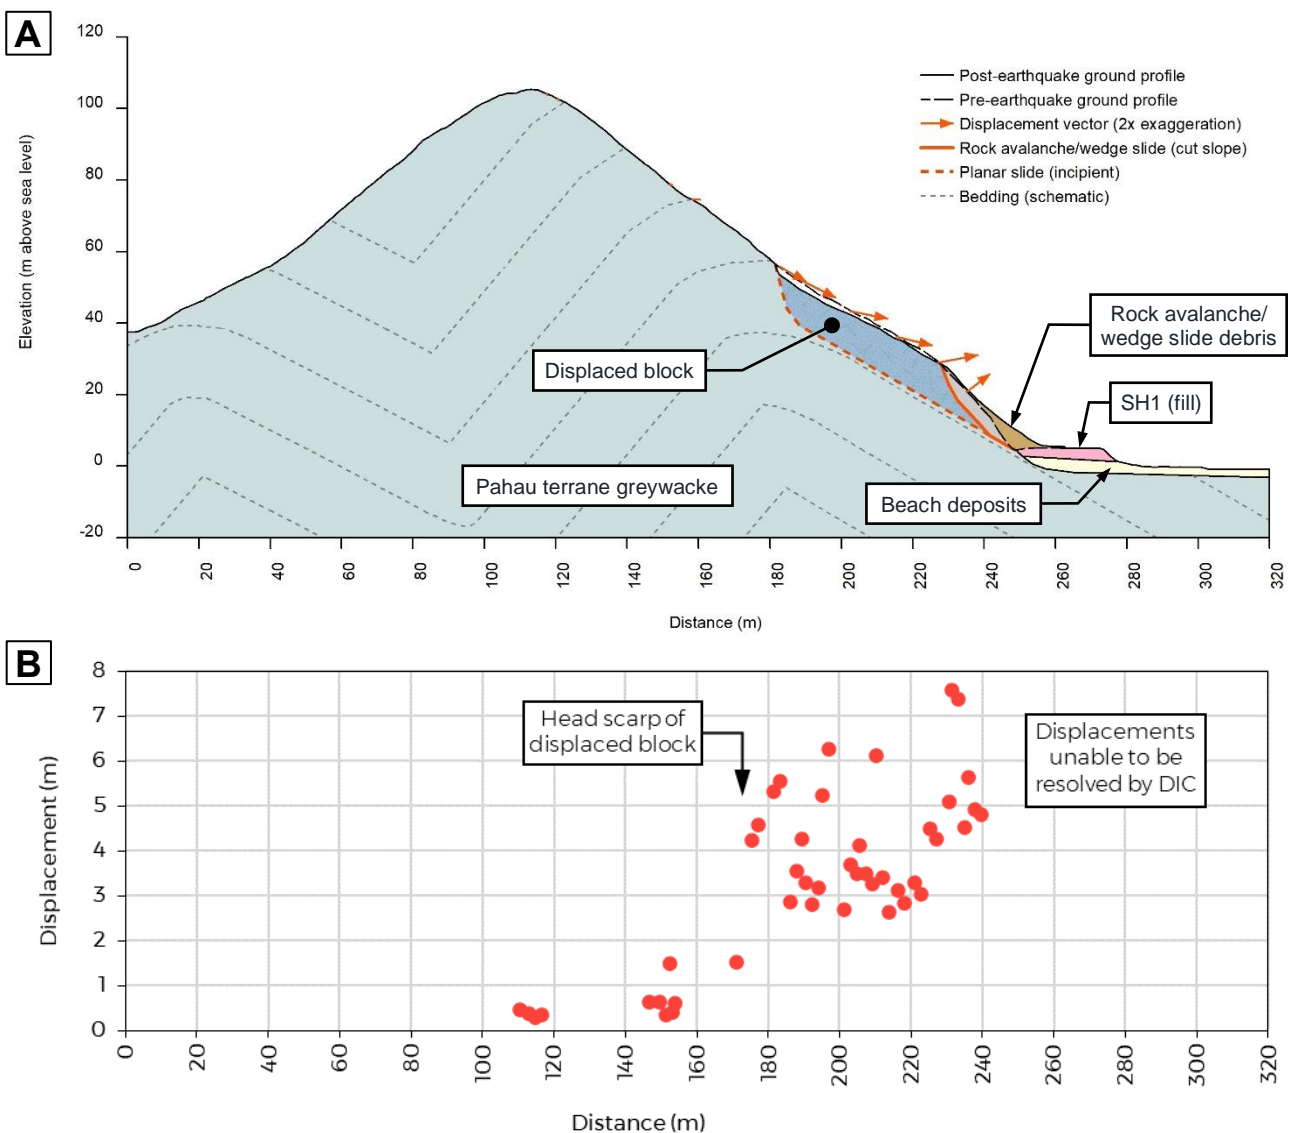
Displacements measured along a swath approximately 10 m wide along the cross section line are shown in Figure 13B. These show displacements of 0.3 m to 0.5 m (and locally up to 1.5 m) in the upper part of the hillslope, near the ridge crest. Discontinuous tension cracks were mapped in this part of the slope (Mason and Brabhaharan, 2023b), which suggests deformation of the top of the ridge consisted of localised fissuring of the surficial soils. Displacements increase significantly below the head scarp of the displaced landslide block, with a mean displacement of 4 m at the head scarp increasing to ~5.5 m (with a maximum of 7.6 m) at the crest of the cut slope. Beyond this point the slope displacements were unable to be resolved due to complete evacuative failure of the cut slope.

As the landslide is located in the lower half of the hillslope, where there would likely be less significant topographic amplification of ground shaking, displacement during the earthquake did not progress sufficiently for the displaced block to evacuate the failure area (c.f. the Okiwi Bay landslide, see Section 4.3). This may indicate the failure surface extended below the road and the landslide was buttressed by the road embankment and shore platform which prevented its transition to an avalanche. However, monitoring of an inclinometer casing installed within one of the vertical boreholes in the road showed <1 mm of displacement beneath road level compared to c. 1500 mm of displacement measured across ground surface extensometers at the landslide head scarp (NCTIR, 2018a), suggesting the failure surface daylighted from the hillslope above road level at the toe of the cut slope. The displacement vectors are inclined out of the slope in the lower part of the landslide, suggesting outwards translation of the landslide block on a failure surface that daylights at the toe of the slope (Figure 13). Exposures of slickensided bedding planes and bedding-parallel joints in the cut slope above the road during earthworks to remove debris also suggest the failure surface intersected the free face at the toe of the cut (NCTIR, 2018f).

Figure 13: Ground model of the Kahutara Bridge site landslide  
 (A) Interpreted cross section. (B) Total (3D) displacements from DIC and manual feature tracking

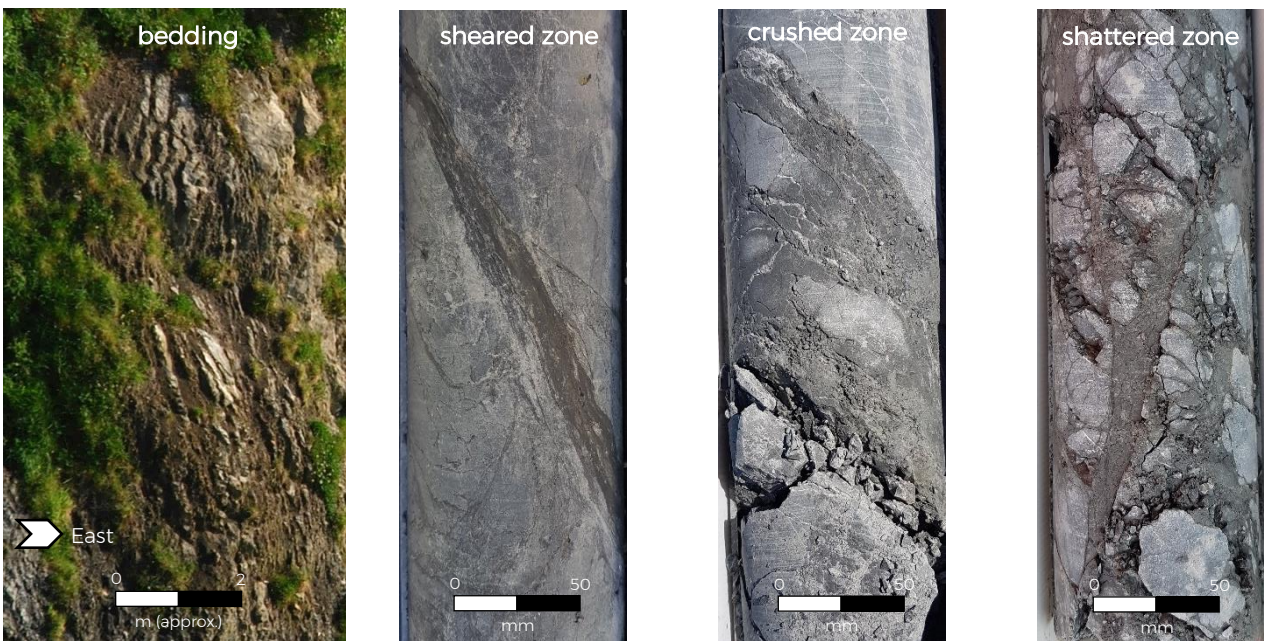
Figure 16: Examples of major defects observed at Okiwi Bay

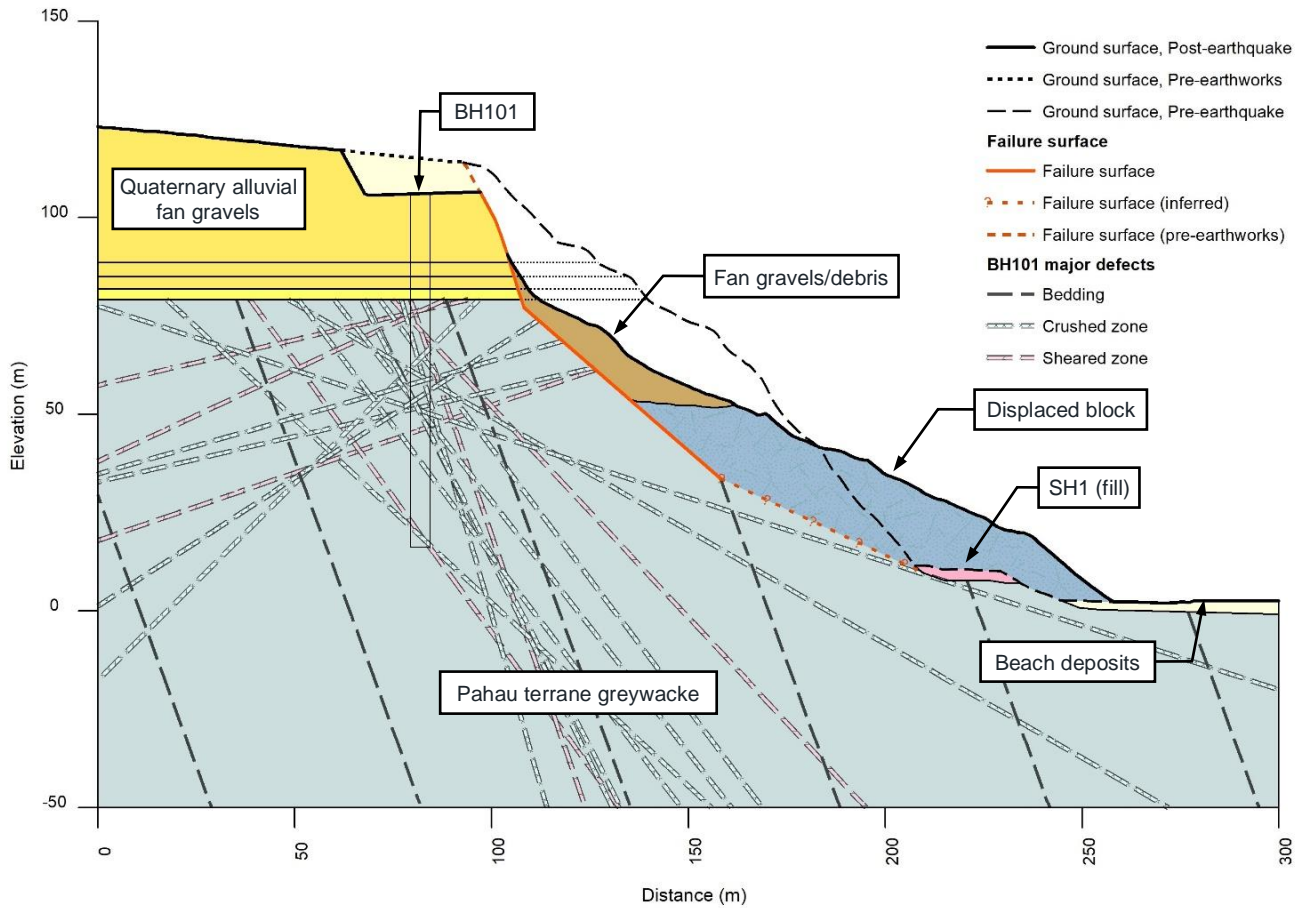
A representative engineering geological profile of the hillslope at the Okiwi Bay landslide is shown in Figure 18. Late Quaternary alluvial fan gravels underlie the terrace surface in the upper part of the slope. These gravels are approximately 35 m in thickness. The upper 25 m consists of well graded sandy gravel and cobbles with boulders and minor silt. Between 25 m and 30 m are interbedded layers of sandy gravel and gravelly silt. Immediately below the sandy gravels and gravelly silt layers is a layer of fine gravel and sand, that is dark bluish grey, wet, and weakly cemented. This unit is inferred to be a remnant of beach or shallow marine gravels that were deposited before the area was uplifted and the area transitioned to fluvial deposition.

The Okiwi Bay landslide was a compound slide, consisting of a rock wedge slide in the upper part of the rock slope and breakout through the rock mass in the lower part of the slope. The landslide mass remained largely intact during translation down the slope with minimal internal deformation. Wedge sliding occurred on intersecting continuous joints and sheared zones in the mudstone to either side of the central ridge. The failure surface was not exposed in the lower part of the slope by the earthworks to reopen the transport corridor. Based on the lack of distortion and rotation of the translated landslide block and the pattern of displacement of the railway lines, it is inferred to have daylighted at the base of the hillslope (Figure 19). The line of the wedge intersection plunges at 41°, which was too steep to daylight from the slope and therefore shear failure extended through the rock mass underneath the ridge, possibly along persistent sheared or crushed zones observed from the site investigations. Translation of the rock block undermined the overlying fan gravels, resulting in toppling/tensile failure extending through the gravels leaving a sub-vertical head scarp.

Figure 18: Ground model for the Okiwi Bay landslide

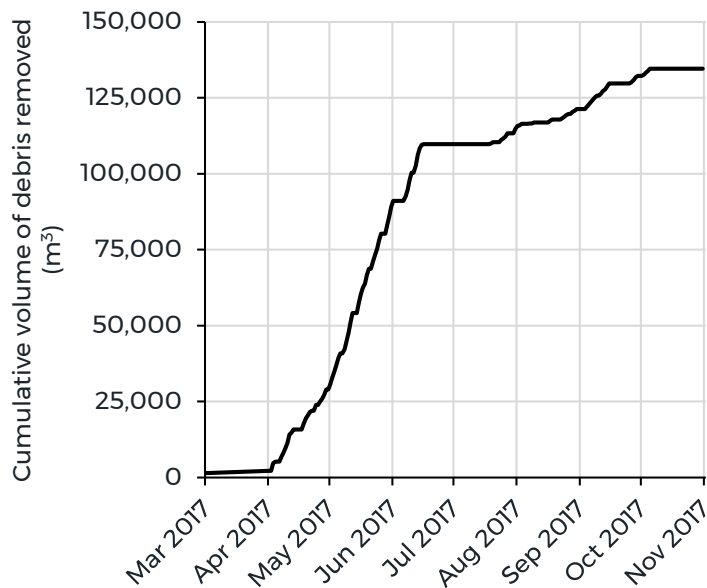
Figure 20: Progress of debris removal from the Okiwi Bay landslide (Source: NCTIR)

Removal of landslide debris from the base of the slope commenced in late March 2017. Debris removal was most intensive from April to June 2017, as shown in Figure 20. During July 2017, earthmoving ceased so the rail tracks could be re-laid. The railway line was reinstated in July 2017 and the line was reopened to freight trains in September 2017.

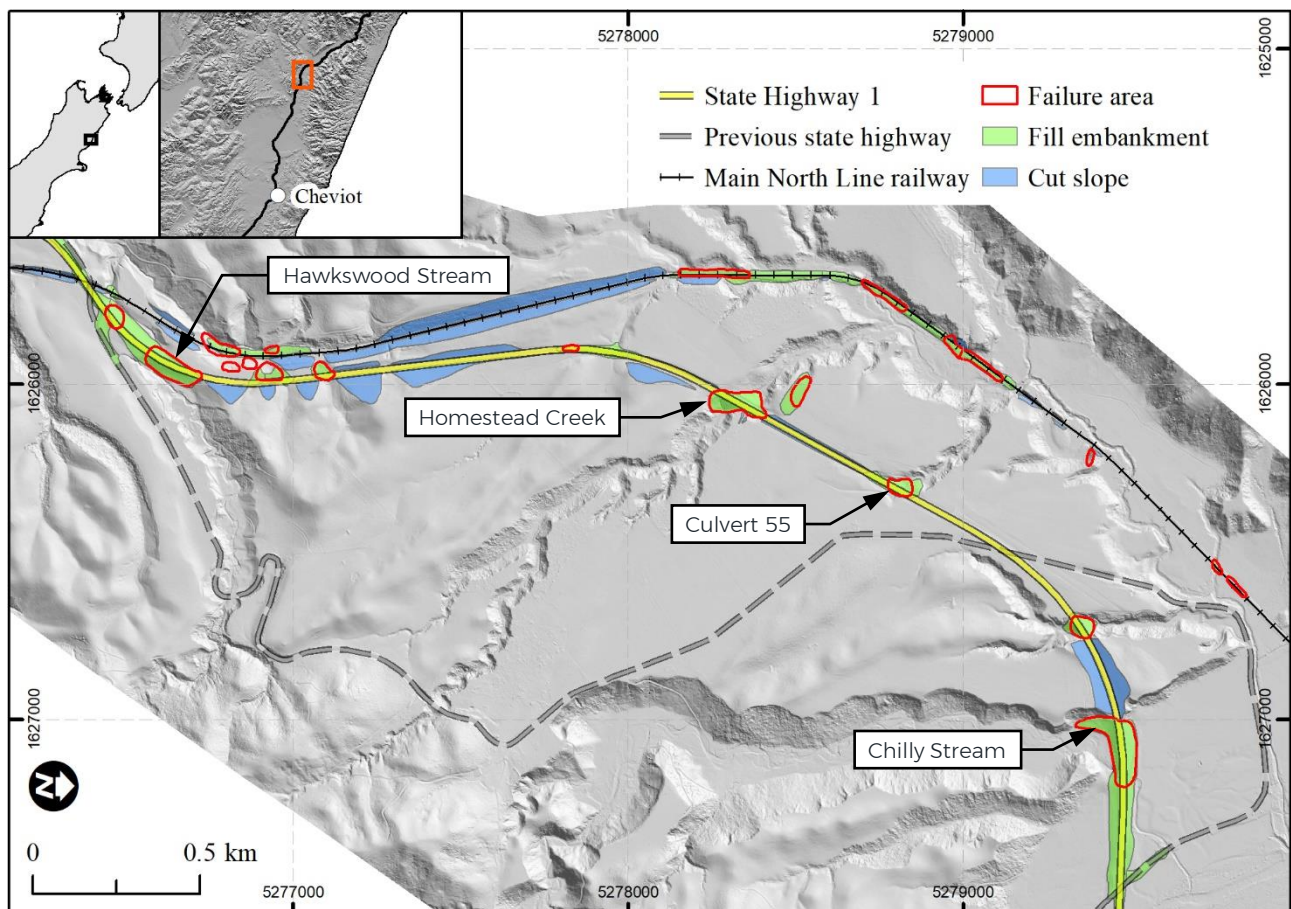
Figure 23: Hillshade relief map of the SH1 Hawkswood to Ferniehurst realignment, with key embankment failure sites highlighted

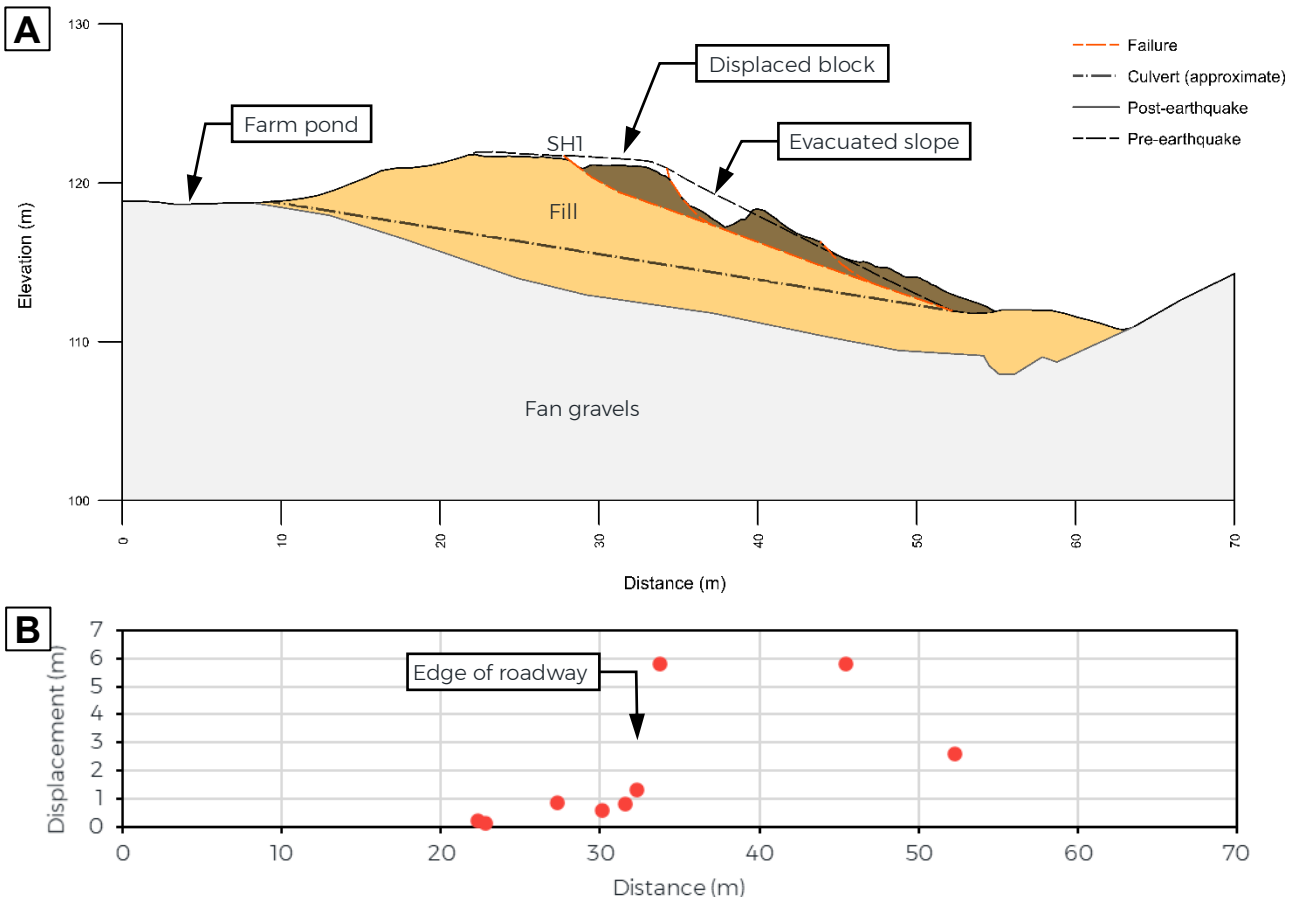
The failed mass displaced 5.8 m downslope, with a ~1 m high scarp forming in the northbound lane, and extensive cracking and settlement throughout the remainder of the fill body; Figure 26A). The mean displacement of the road surface was c. 0.5 m, with a sharp increase across the head scarp of the main part of the failure near the crest of the fill slope. The displacement of the landslide also caused separation of the concrete pipe sections of the culvert within the embankment. Slope displacements were measured in GIS by identifying displaced ground surface features in pre- and post-earthquake aerial photos, supplemented by field-based measurement of horizontal and vertical offsets of the road surface across

Figure 26: (A) Cross section and (B) displacement profile through the Culvert 55 embankment

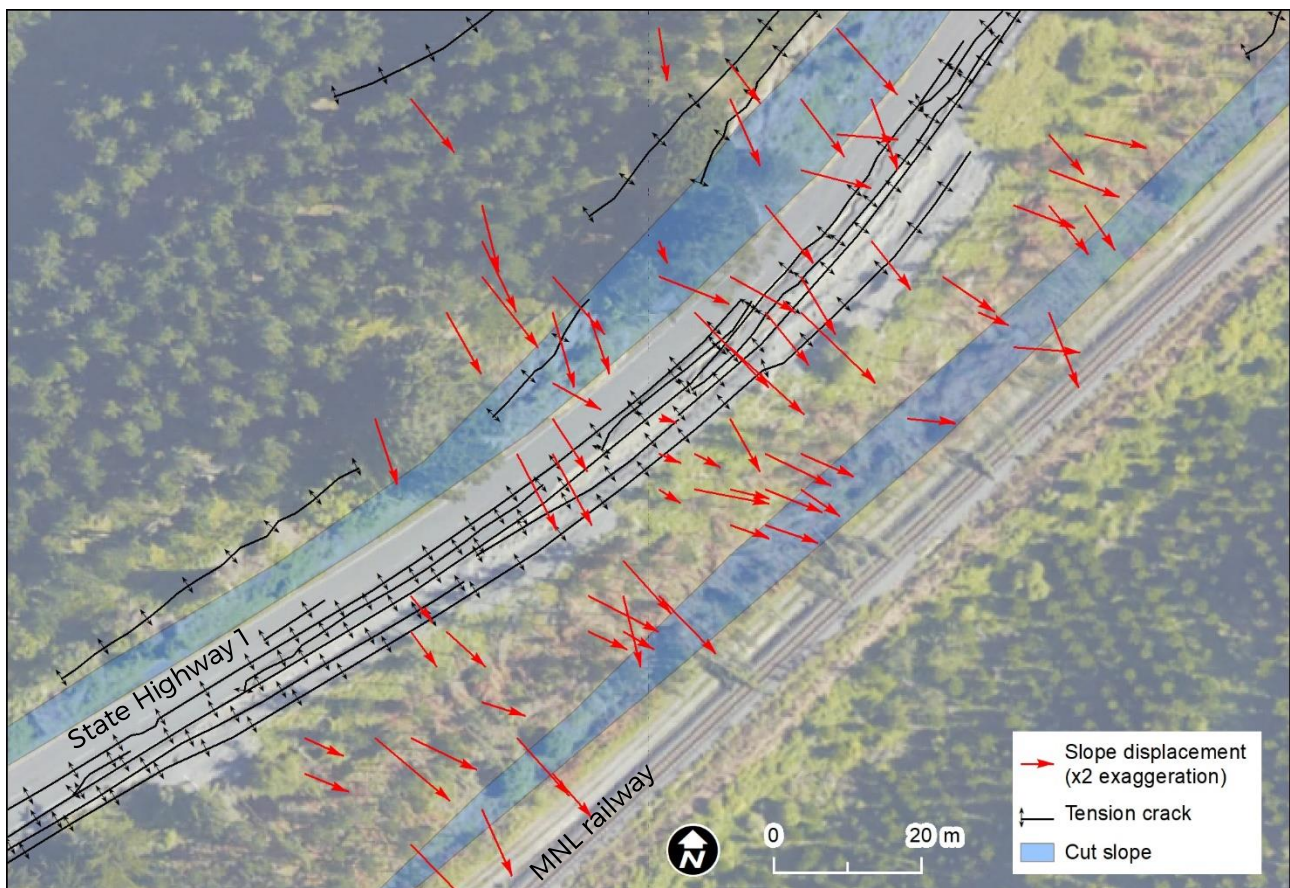
The strong ground shaking triggered a series of fill embankment and cut slope failures along the 700 m long section of SH1 through the site. Assessment of coseismic slope displacements was carried out by DIC and GIS-based measurement using pre- and post-earthquake aerial photos (shown in Figure 31). Representative displacements are shown on the cross section profile (Figure 32A), and displacements measured along a swath approximately 20 m either side of the cross section line are shown in Figure 32B. These show the magnitude of displacements are consistent from the upper slope to the lower slope (generally between 3.3 m and 6.6 m, with a mean displacement of 4.8 m). The maximum displacements (between 7 m and 7.8 m) occurred along the margins of the road corridor, with outward displacement of the toe of the cut slope above the road and downslope displacement of the gabion wall and fill embankment below the road.

Figure 31: Slope displacements at The Sandpit from DIC analysis, field mapping and GIS-based feature tracking

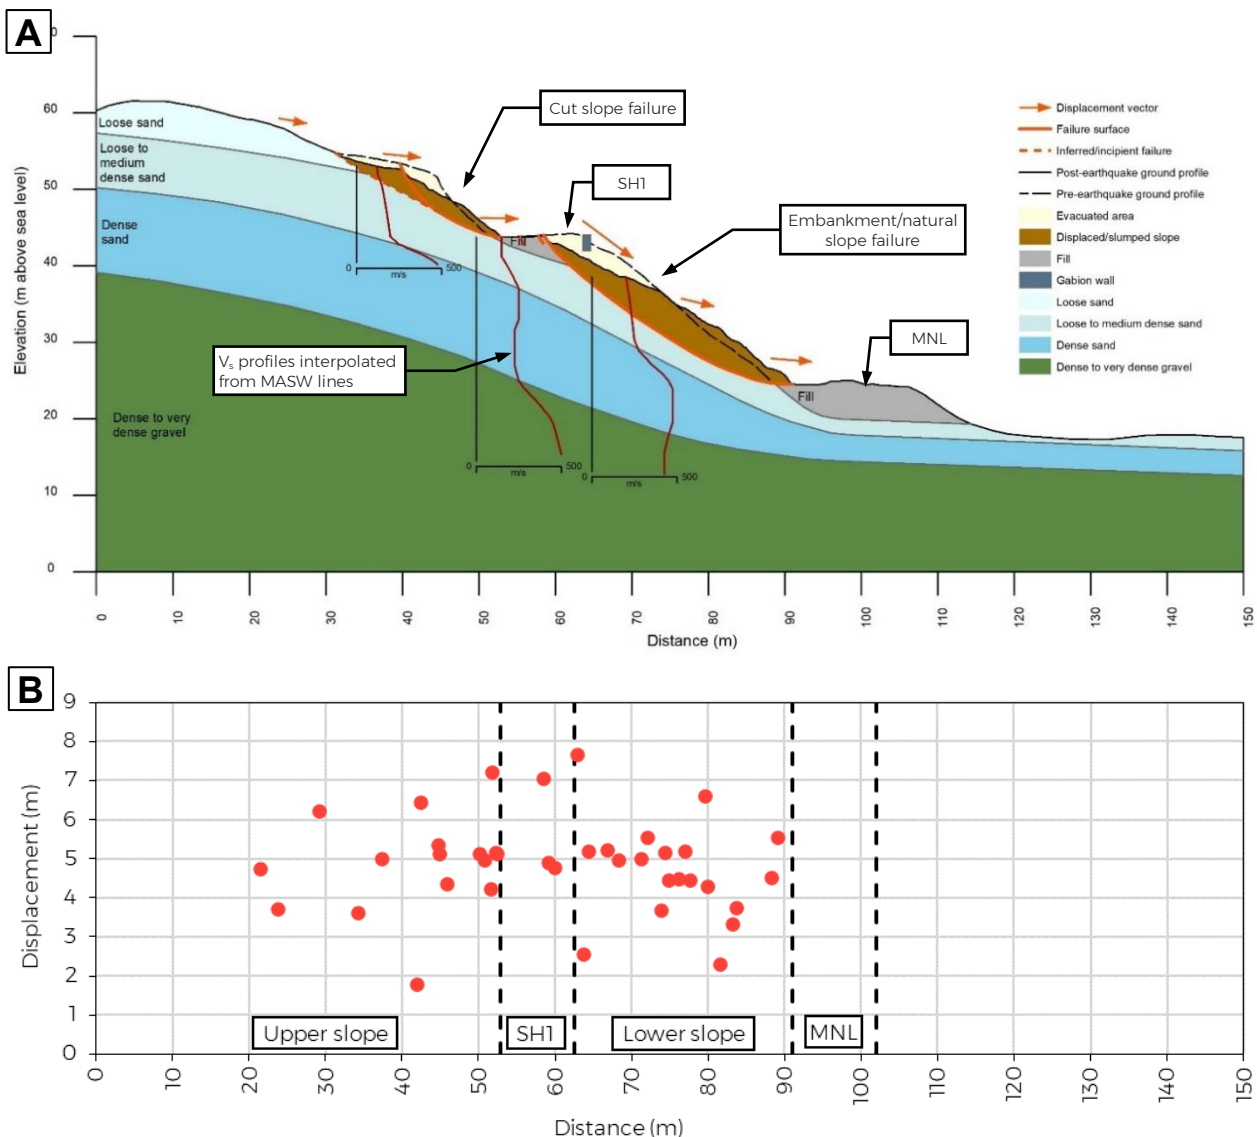
Figure 32: (A) Engineering geological profile of failures (B) slope displacements at Sandpit site

The principal failure mechanisms were translational sliding of the fill embankment and natural slope below the road and translational sliding of the over-steepened cut slope above the road (Figure 32). Typical failures are shown in Figure 33.

The failure of the slope below the road consisted of translational or semi-rotational displacement along a slip surface extending from the approximate centre of the road to the toe of the slope (daylighting at or near the level of the railway) and inferred to lie at c. 5 m depth in the centre of the slope. Displacement at the top of the head scarp was around 1.5 m to 2 m at an angle of 55° below horizontal. The gabion walls and the crest of the fill slope displaced about 7 m downslope at angles of 30° to 45°, and the lower parts of the slope displaced between 3.5 m and 5.5 m at -15°.

The failure of the cut slope above the road was a translational sliding failure, with a 3.5 m deep failure surface dipping at 30°. The landslide mass consists of two parts: the frontal part, consisting of the slope from road level to ~5 m behind the crest of the cut slope, and the rear part, extending to ~13 m behind the crest of the cut slope. The failure surface behind the cut slope is approximately circular in shape, shallowing from 60° at the head scarp to intersect the main failure surface (30°) at the toe of the cut slope. The rear part of the landslide displaced towards the road between 0.5 m and 1.5 m at an angle of 30° to 40° (steepening closer to the road). Deformation of the rear part of the landslide manifested as tension cracks and tilted trees.

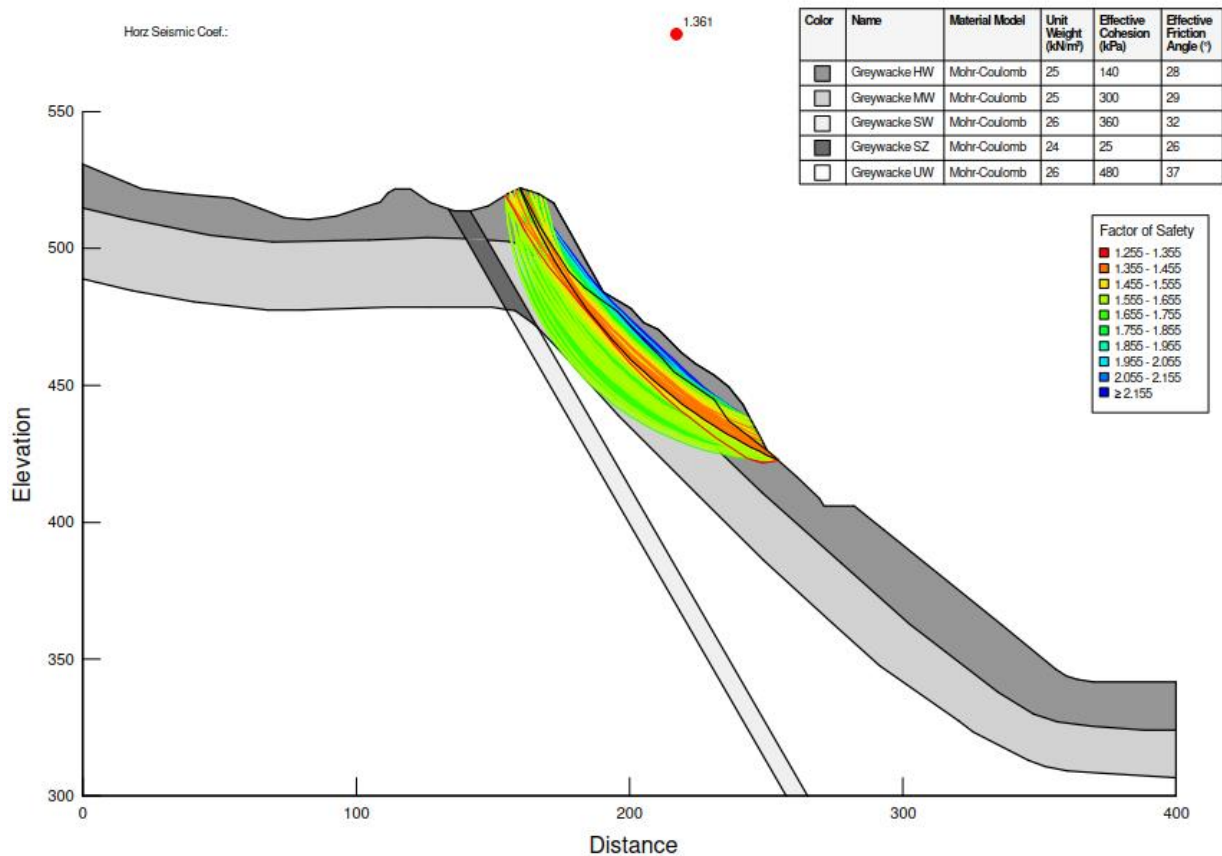
Awatere Gorge, static stability analysis

- Field observations at this site suggest that displacement of the slope during the earthquake resulted in brittle kinematic failure, with strength loss and disintegration of the rock mass. It is not known what amount of strain the rock mass was able to accommodate before disintegrating and transitioning into a debris avalanche. Consequently, displacements estimated with a Newmark rigid sliding block approach for this brittle rock mass cannot be compared reliably to slope performance thresholds based on displacement amounts.

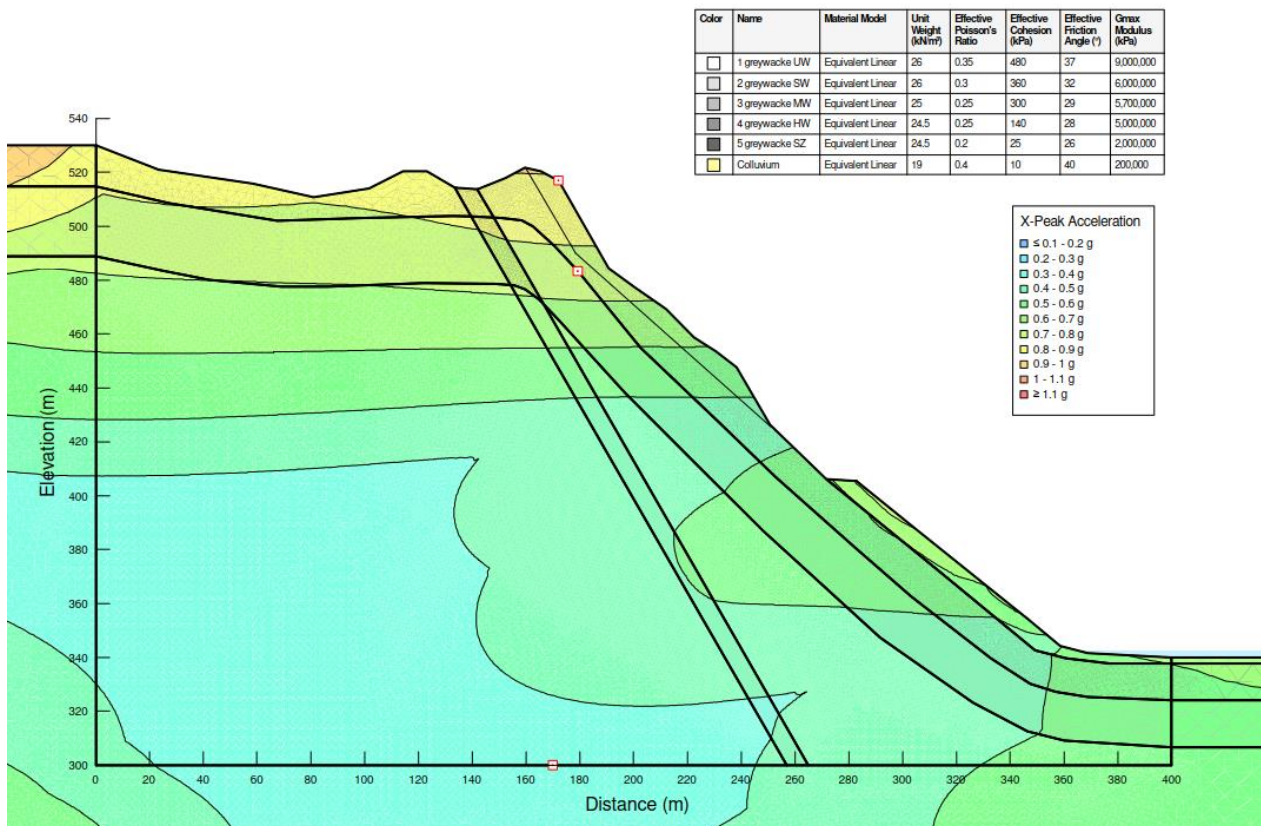
Awatere Gorge dynamic analysis, contours of peak horizontal acceleration

- Seismicity effects such as topographic amplification are likely to have contributed significantly to this landslide. The slope crest PGA simulated by the dynamic slope analysis was approximately 1.4x higher than the free field PGA, and significantly larger displacements were derived from the dynamic analysis relative to the semi-empirical methods. Directivity or wave trapping effects may also have had a significant influence on the landslide, as it occurred at the northern end of an elongated and sharp ridgeline that trends perpendicular to the fault ruptures on the eastern side of the Kaikōura ranges. However, there is insufficient data to enable analysis of these effects, and is beyond the scope of this assessment.

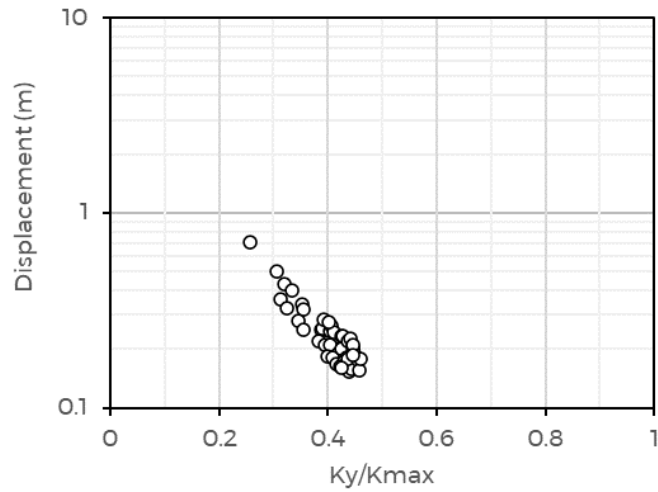
Awatere Gorge simulated Newmark ground displacements, shown as a function of the ratio of the yield acceleration ( $K_y$ ) to the average acceleration of the landslide mass ( $K_{max}$ ) for the 50 slide surfaces with the lowest factors of safety.

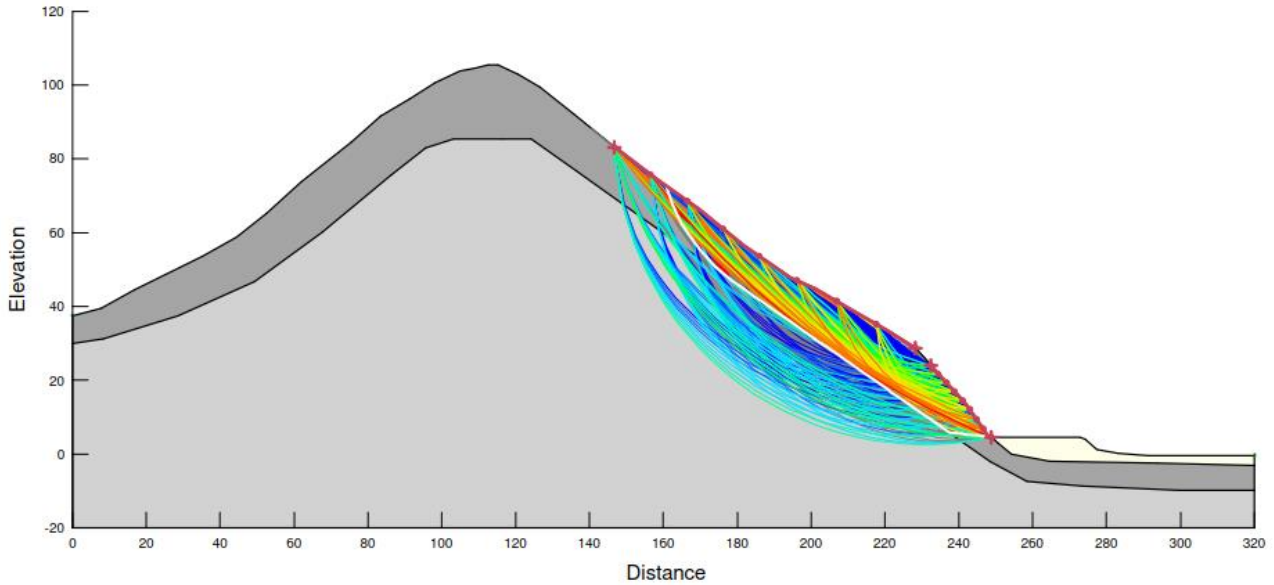
Kahutara Bridge seismic back-analysis (critical acceleration = 0.21 g)

- The actual displacements of the landslide mass are much larger (7.6 m) and indicates the reduction of strength along the sliding surface in brittle rock materials.

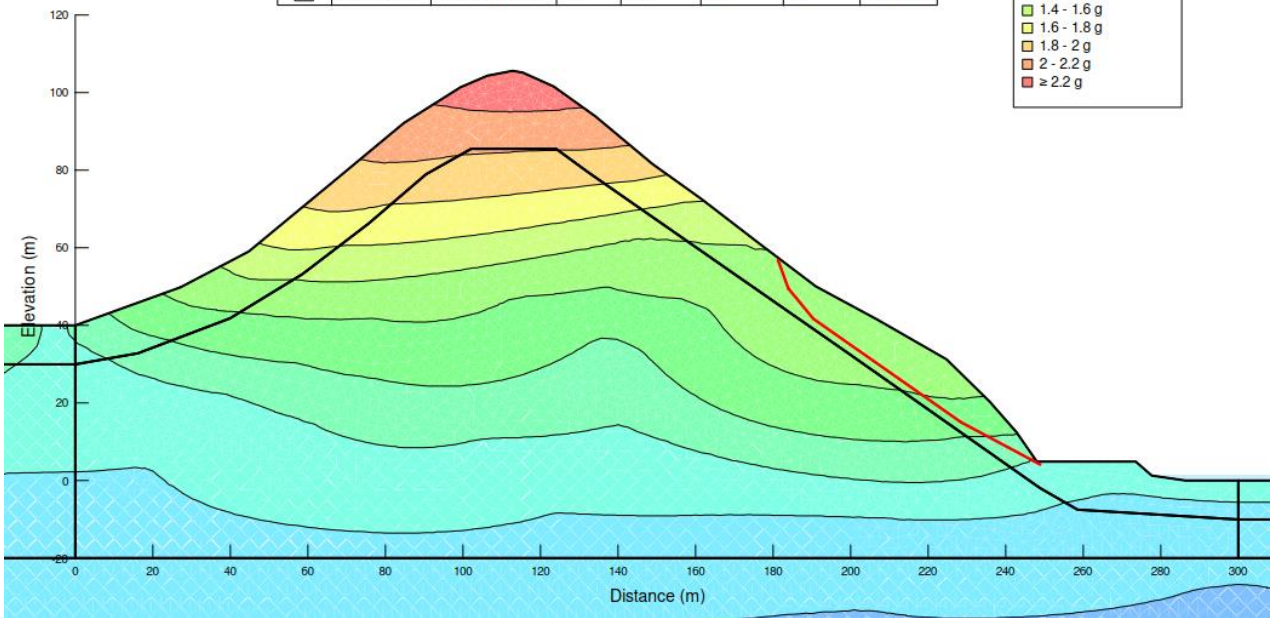
Kahutara Bridge dynamic analysis, contours of peak horizontal acceleration

- Topographic amplification was significant in the response of the ridge to the earthquake shaking, with the Quake/W model showing amplification of the ridge crest PGA on the order of 1.1 to 1.7x the free field PGA.

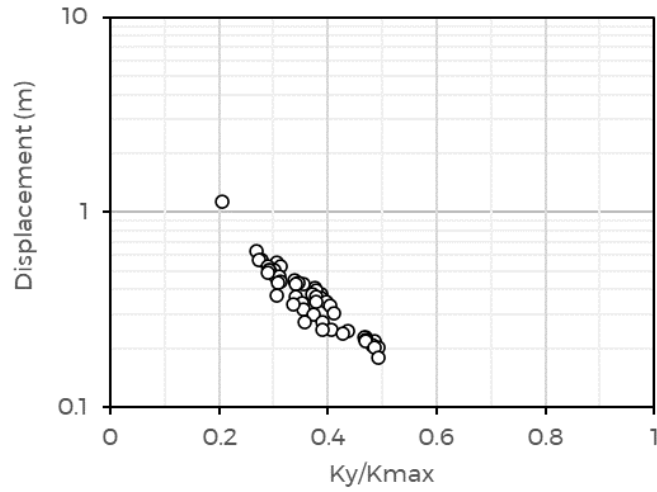
Kahutara Bridge simulated Newmark ground displacements, shown as a function of the ratio of the yield acceleration ( $K_y$ ) to the average acceleration of the landslide mass ( $K_{max}$ ) for the 50 slide surfaces with the lowest factors of safety.

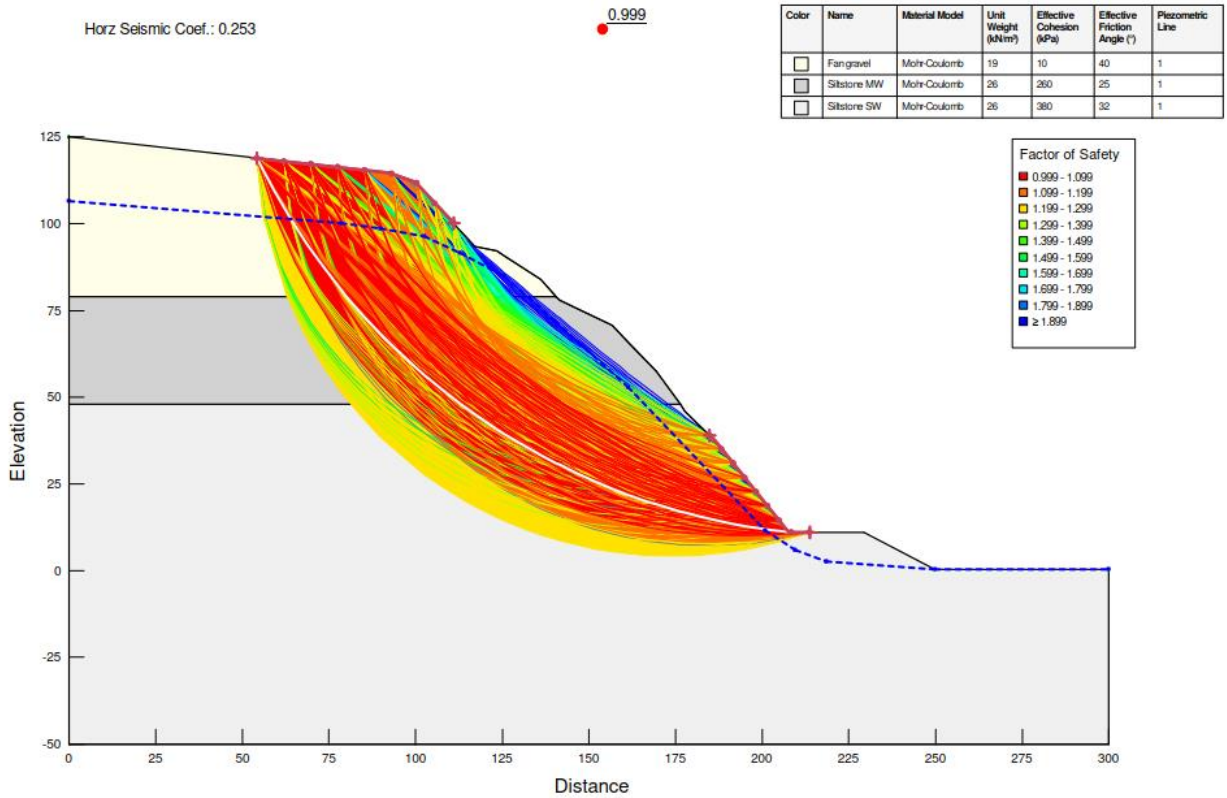
Okiwi Bay seismic back-analysis (critical acceleration = 0.25 g)

- These large observed displacements were much larger than those calculated during either the decoupled analyses or the semi-empirical methods. This demonstrates why such displacement analyses cannot be reliably used in the analyses of slopes comprising brittle materials and brittle failure mechanisms.

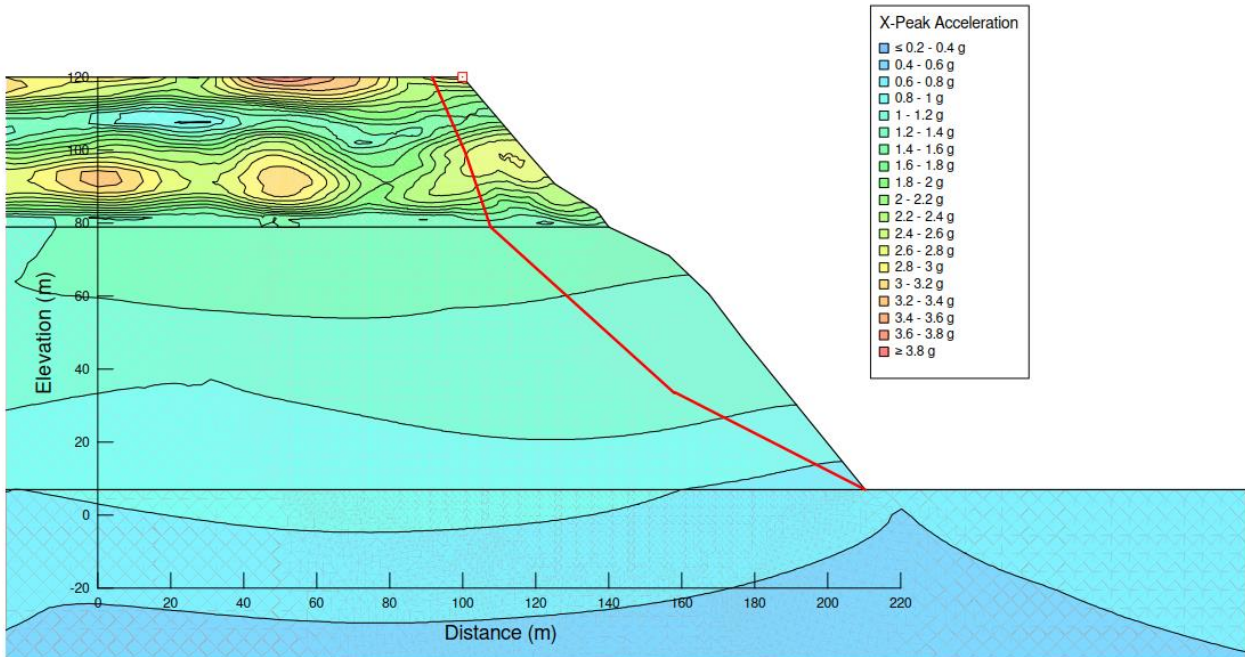
Okiwi Bay dynamic analysis, contours of peak horizontal acceleration

- The combined effects of the steep, high terrace slope and the impedance contrast between the 30 m thick sequence of fan gravels and underlying greywacke bedrock resulted in large site amplification of ground shaking in the dynamic slope analysis, with the peak ground acceleration at the crest approximately 3.8x the free field acceleration. The contribution of topographic amplification to the overall site amplification has not been assessed here.

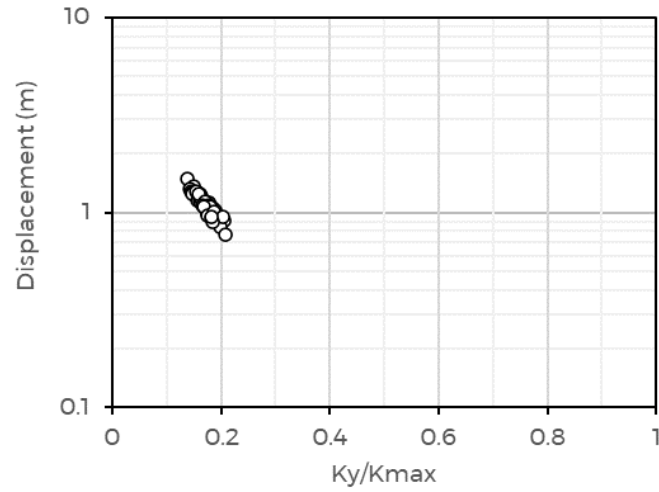
Okiwi Bay simulated Newmark ground displacements, shown as a function of the ratio of the yield acceleration ( $K_y$ ) to the average acceleration of the landslide mass ( $K_{max}$ ) for the 50 slide surfaces with the lowest factors of safety.

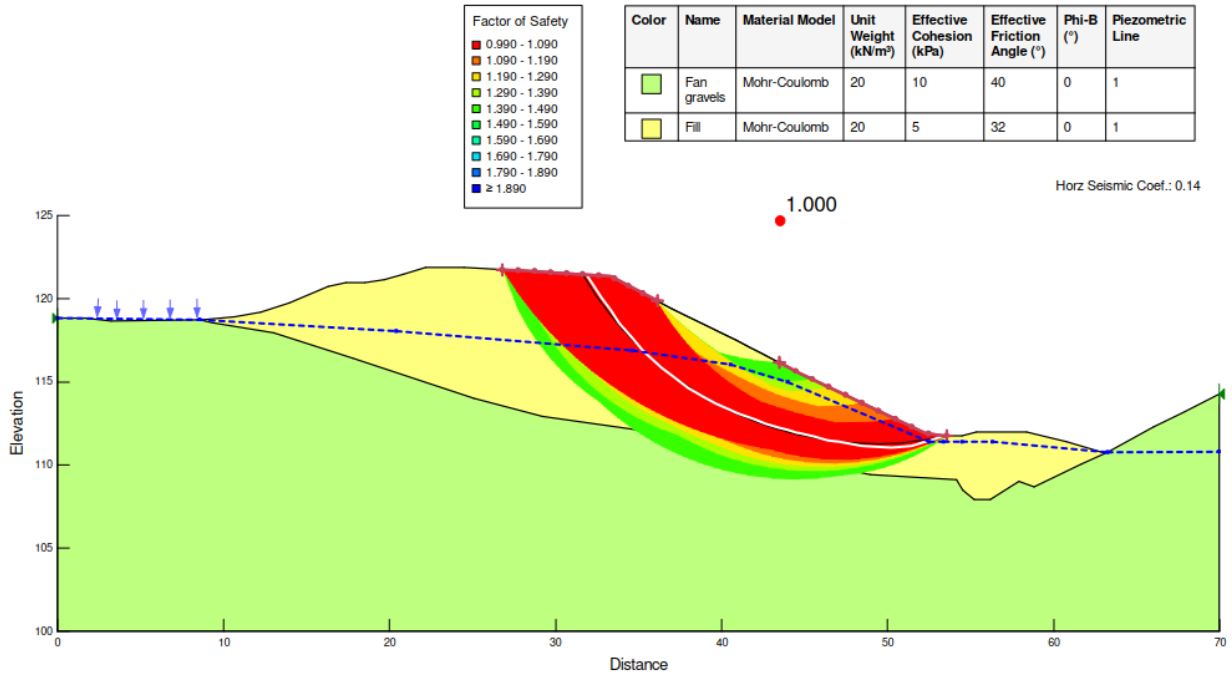
Culvert 55 seismic back-analysis (critical acceleration = 0.14 g)

- These observations reinforce that the semi-empirical methods suggested by the Bridge Manual for assessing slope stability and displacement provide a sound basis for design. In order to achieve resilience in the performance of fill embankments, provided resilience-based design approaches to limit displacements to small magnitudes, sound construction practices and proactive maintenance of drainage assets are important.

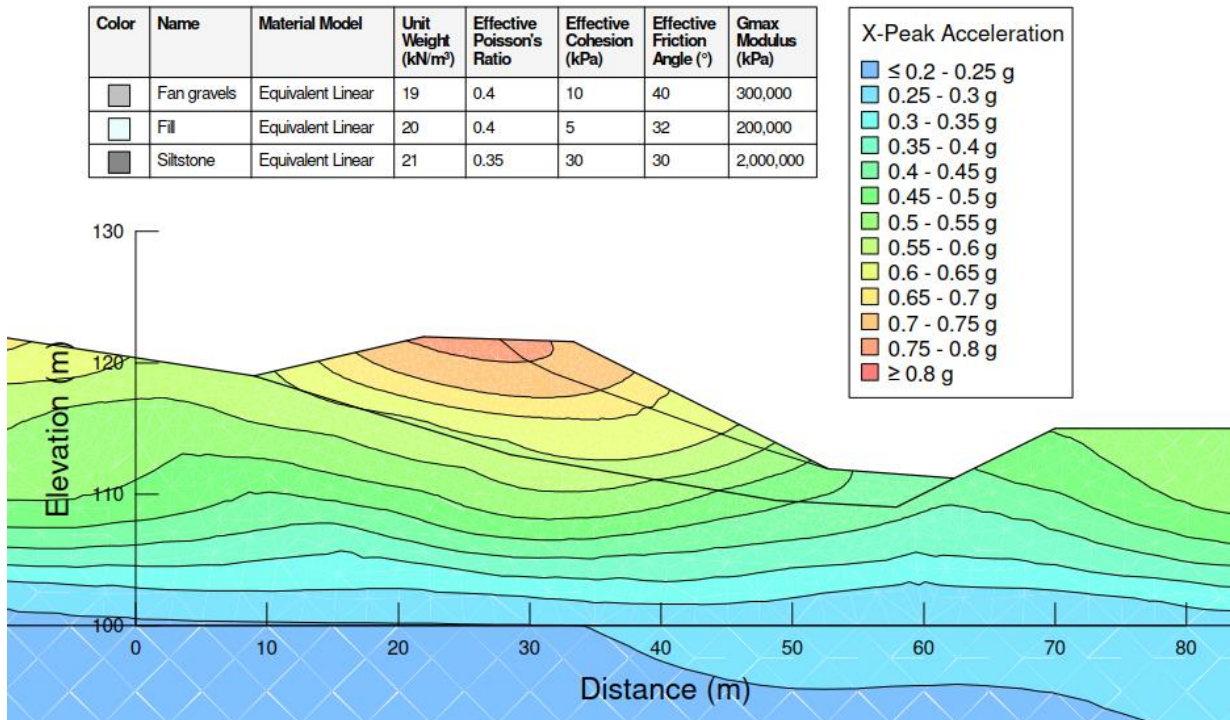
Culvert 55 dynamic analysis, contours of peak horizontal acceleration

- Even with a modest 10 m height of embankment, the dynamic analyses suggested an amplification of PGA of the order of 1.4 times the free field acceleration.

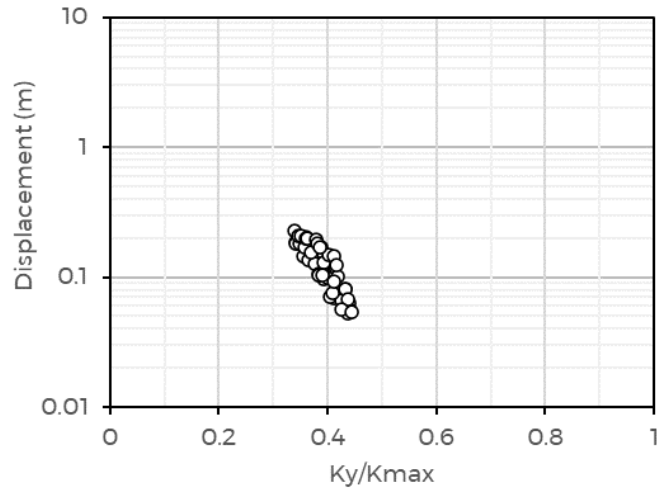
Culvert 55 simulated Newmark ground displacements, shown as a function of the ratio of the yield acceleration ( $K_y$ ) to the average acceleration of the landslide mass ( $K_{max}$ ) for the 50 slide surfaces with the lowest factors of safety.

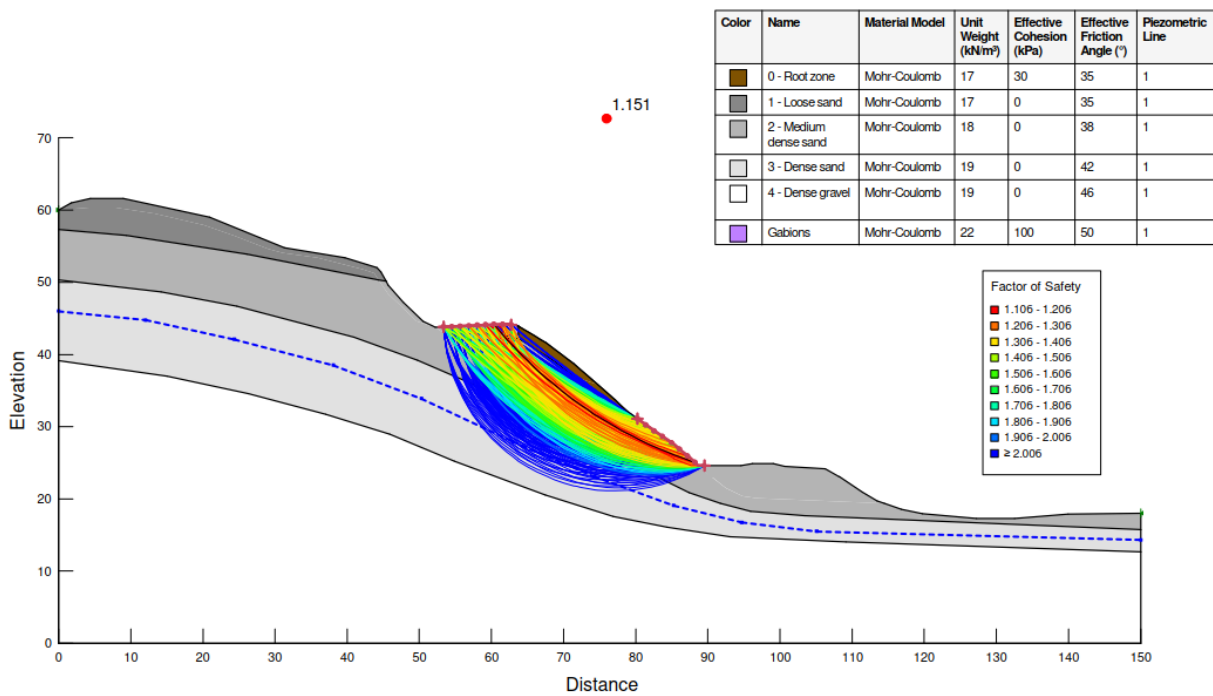
The Sandpit static stability analysis

- The sequence of loose to medium dense sands near to the ground surface result in a low static factor of safety and low yield acceleration. Variability in the modelled PGA between the Shakemap, Bradley and USGS models results in a wide range of predicted displacements using the semi-empirical methods suggested in the Bridge Manual. Similar ranges of magnitudes of displacement were predicted by the decoupled analysis. The pseudostatic factor of safety and modelled coseismic displacements were outside the limits specified by the Bridge Manual, and the total (i.e. post-yield) displacement of the failed mass was 7.8 metres.
