# Kaikōura Earthquake-Induced Landscape Dynamics Research

## Theme 6 – Assessment Report

Report No: GER 2023/14  
Date: 13 June 2023  
Reference: 5-C3418.00  
Status: Rev A

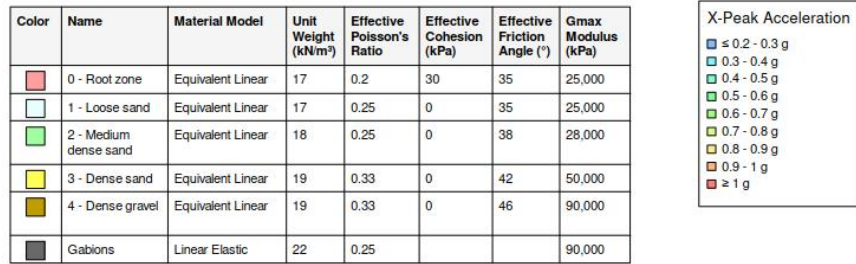
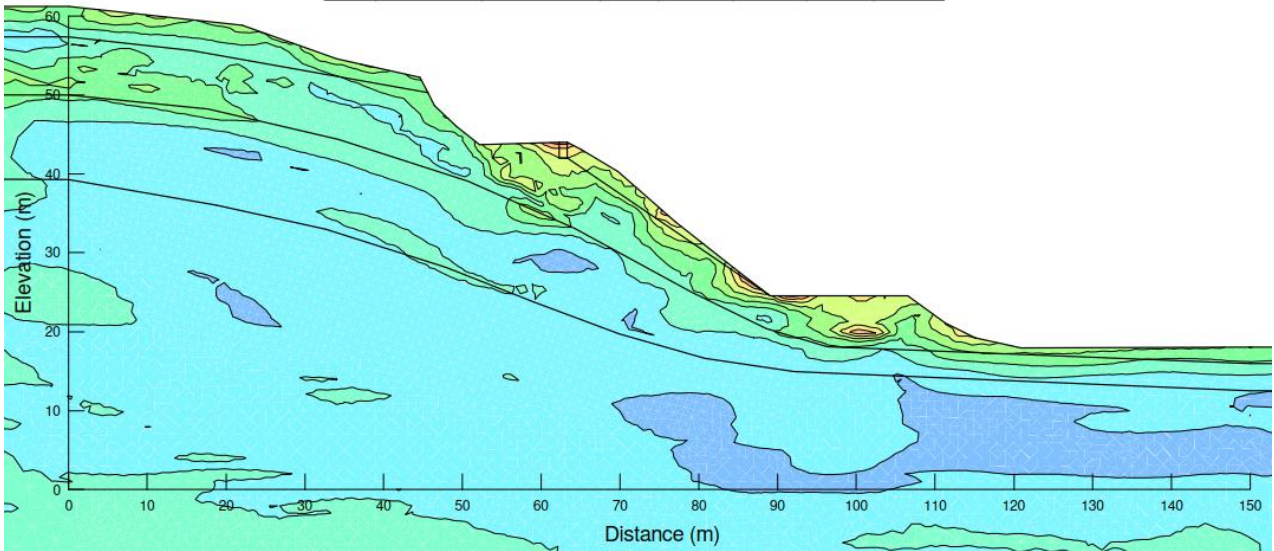
The Sandpit dynamic analysis, contours of peak horizontal acceleration

- The PGA simulated by the dynamic slope analysis at the road level was approximately 1.1x higher than the free field PGA.

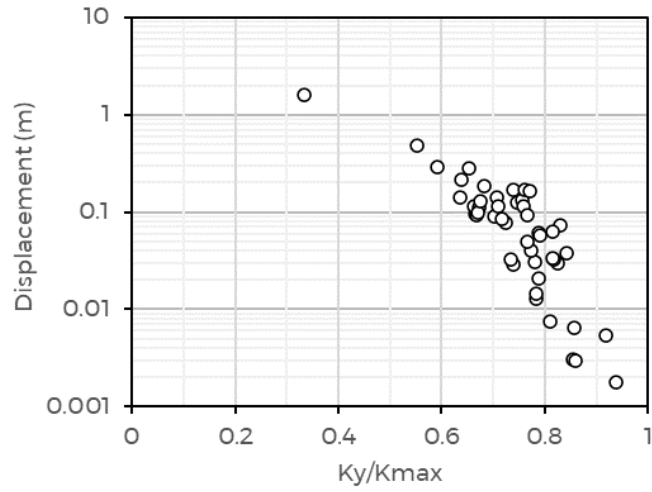
The Sandpit simulated Newmark ground displacements, shown as a function of the ratio of the yield acceleration ( $K_y$ ) to the average acceleration of the landslide mass ( $K_{max}$ ) for the 50 slide surfaces with the lowest factors of safety.
