Assessing landslide dam hazards in Aotearoa New Zealand: a data driven approach.

Regine Morgenstern¹, Andrea Wolter¹, Chris Massey¹, Brenda Rosser¹, Simon C. Cox² and Biljana Lukovic¹

Assessing landslide dam hazards in Aotearoa New Zealand: a data driven approach

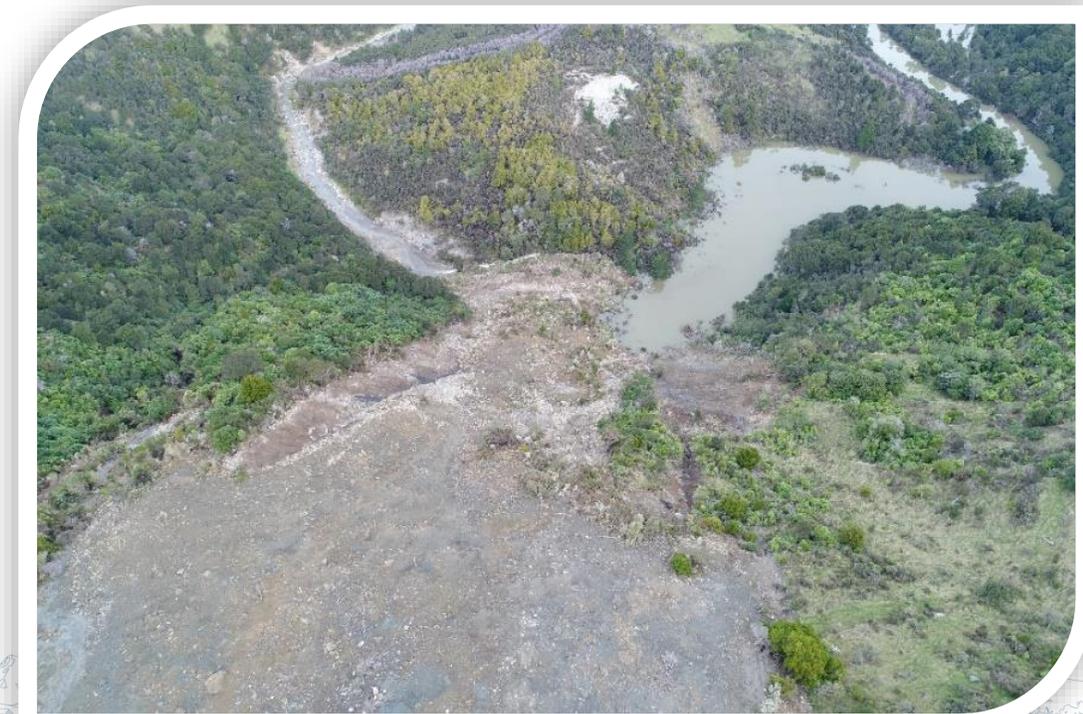
Dimensionless Blockage Index (DBI) tool

Probability of dam failure: regional-scale assessment based on dam geometry and catchment area (stream power)

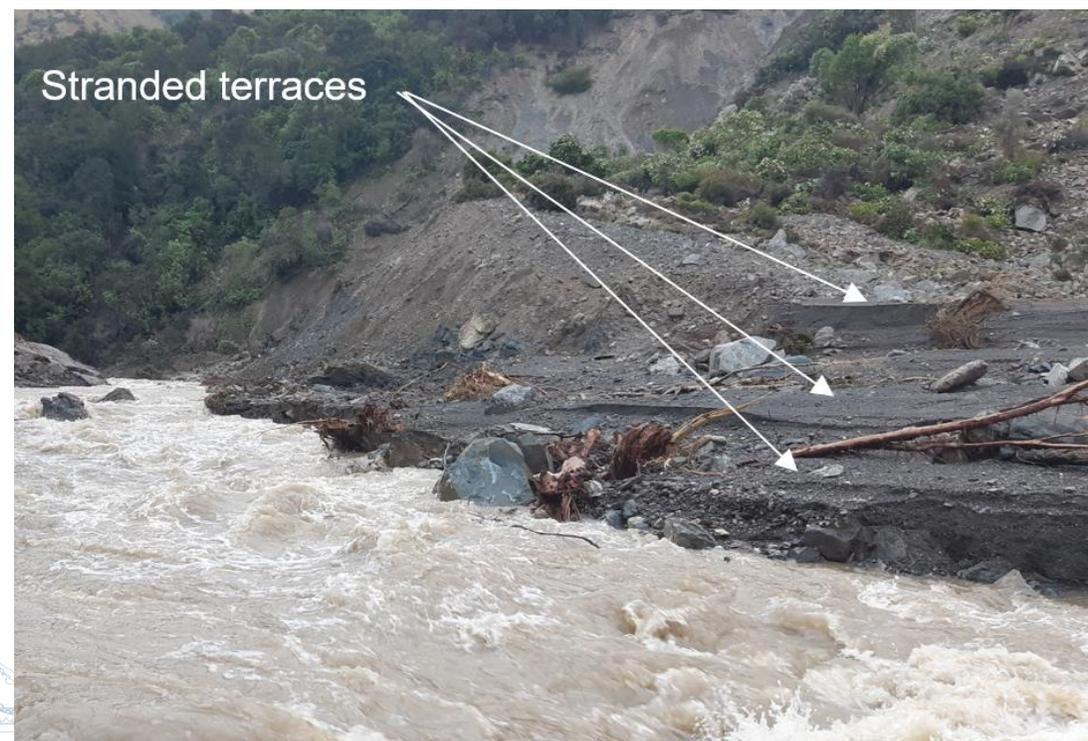
Kaiwhata – flood extent

Trash line surveying – field mapping of floodplain day after the event

- Entire floodplain inundated with **1-2 m** of water (max **600 m wide** and **6 m depth**)
- Failure occurred in **multiple pulses**
- No one hurt, no buildings or infrastructure damaged

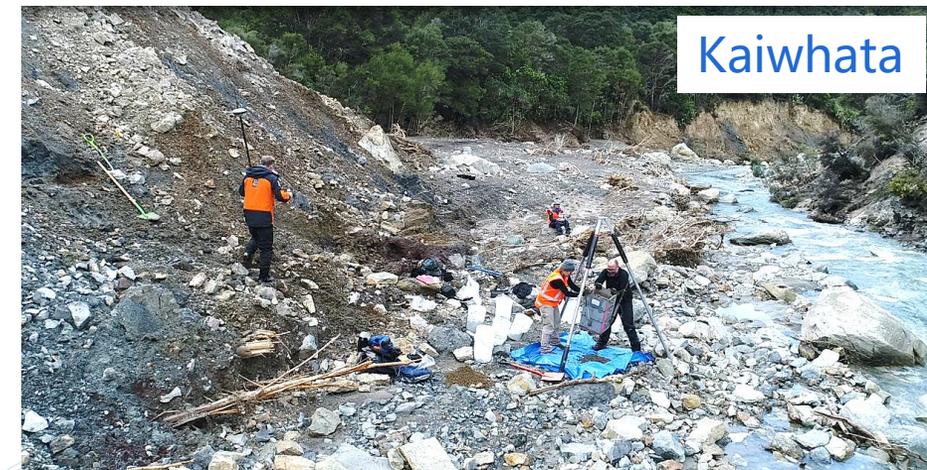
Kaiwhata vs Hapuku landslide dams

Kaiwhata	Hapuku
Emplacement mechanism	Debris avalanche, single event	Rock slide, multiple pulses, highly sheared, debris consolidated post-emplacement
Source material type	Soft mudstone	Hard greywacke
Source material UCS	2 MPa	100 MPa
Source material age	Neogene (23-2.6 Ma)	Early Cretaceous (145-100 Ma)
Deposit D50	3 mm	4-30 mm
Lake volume (lowest point on dam crest)	1 M m ³	1.2 M m ³
Peak breach discharge	900 m ³ /s	12 m ³ /s
Breach type	Complete, rapid within 1.5 hours, overtopping	Partial, gradual headward erosion over ~1 month, followed by multiple overtopping events
Longevity	4 weeks	4.5 months (partial); 7+ years
Lake status	Fully evacuated	Remnant lake
